WARREN PUBLIC SAFETY COMPLEX FEASIBILITY STUDY

TOWN OF WARREN, MASSACHUSETTS

ISSUED: OCTOBER 2024

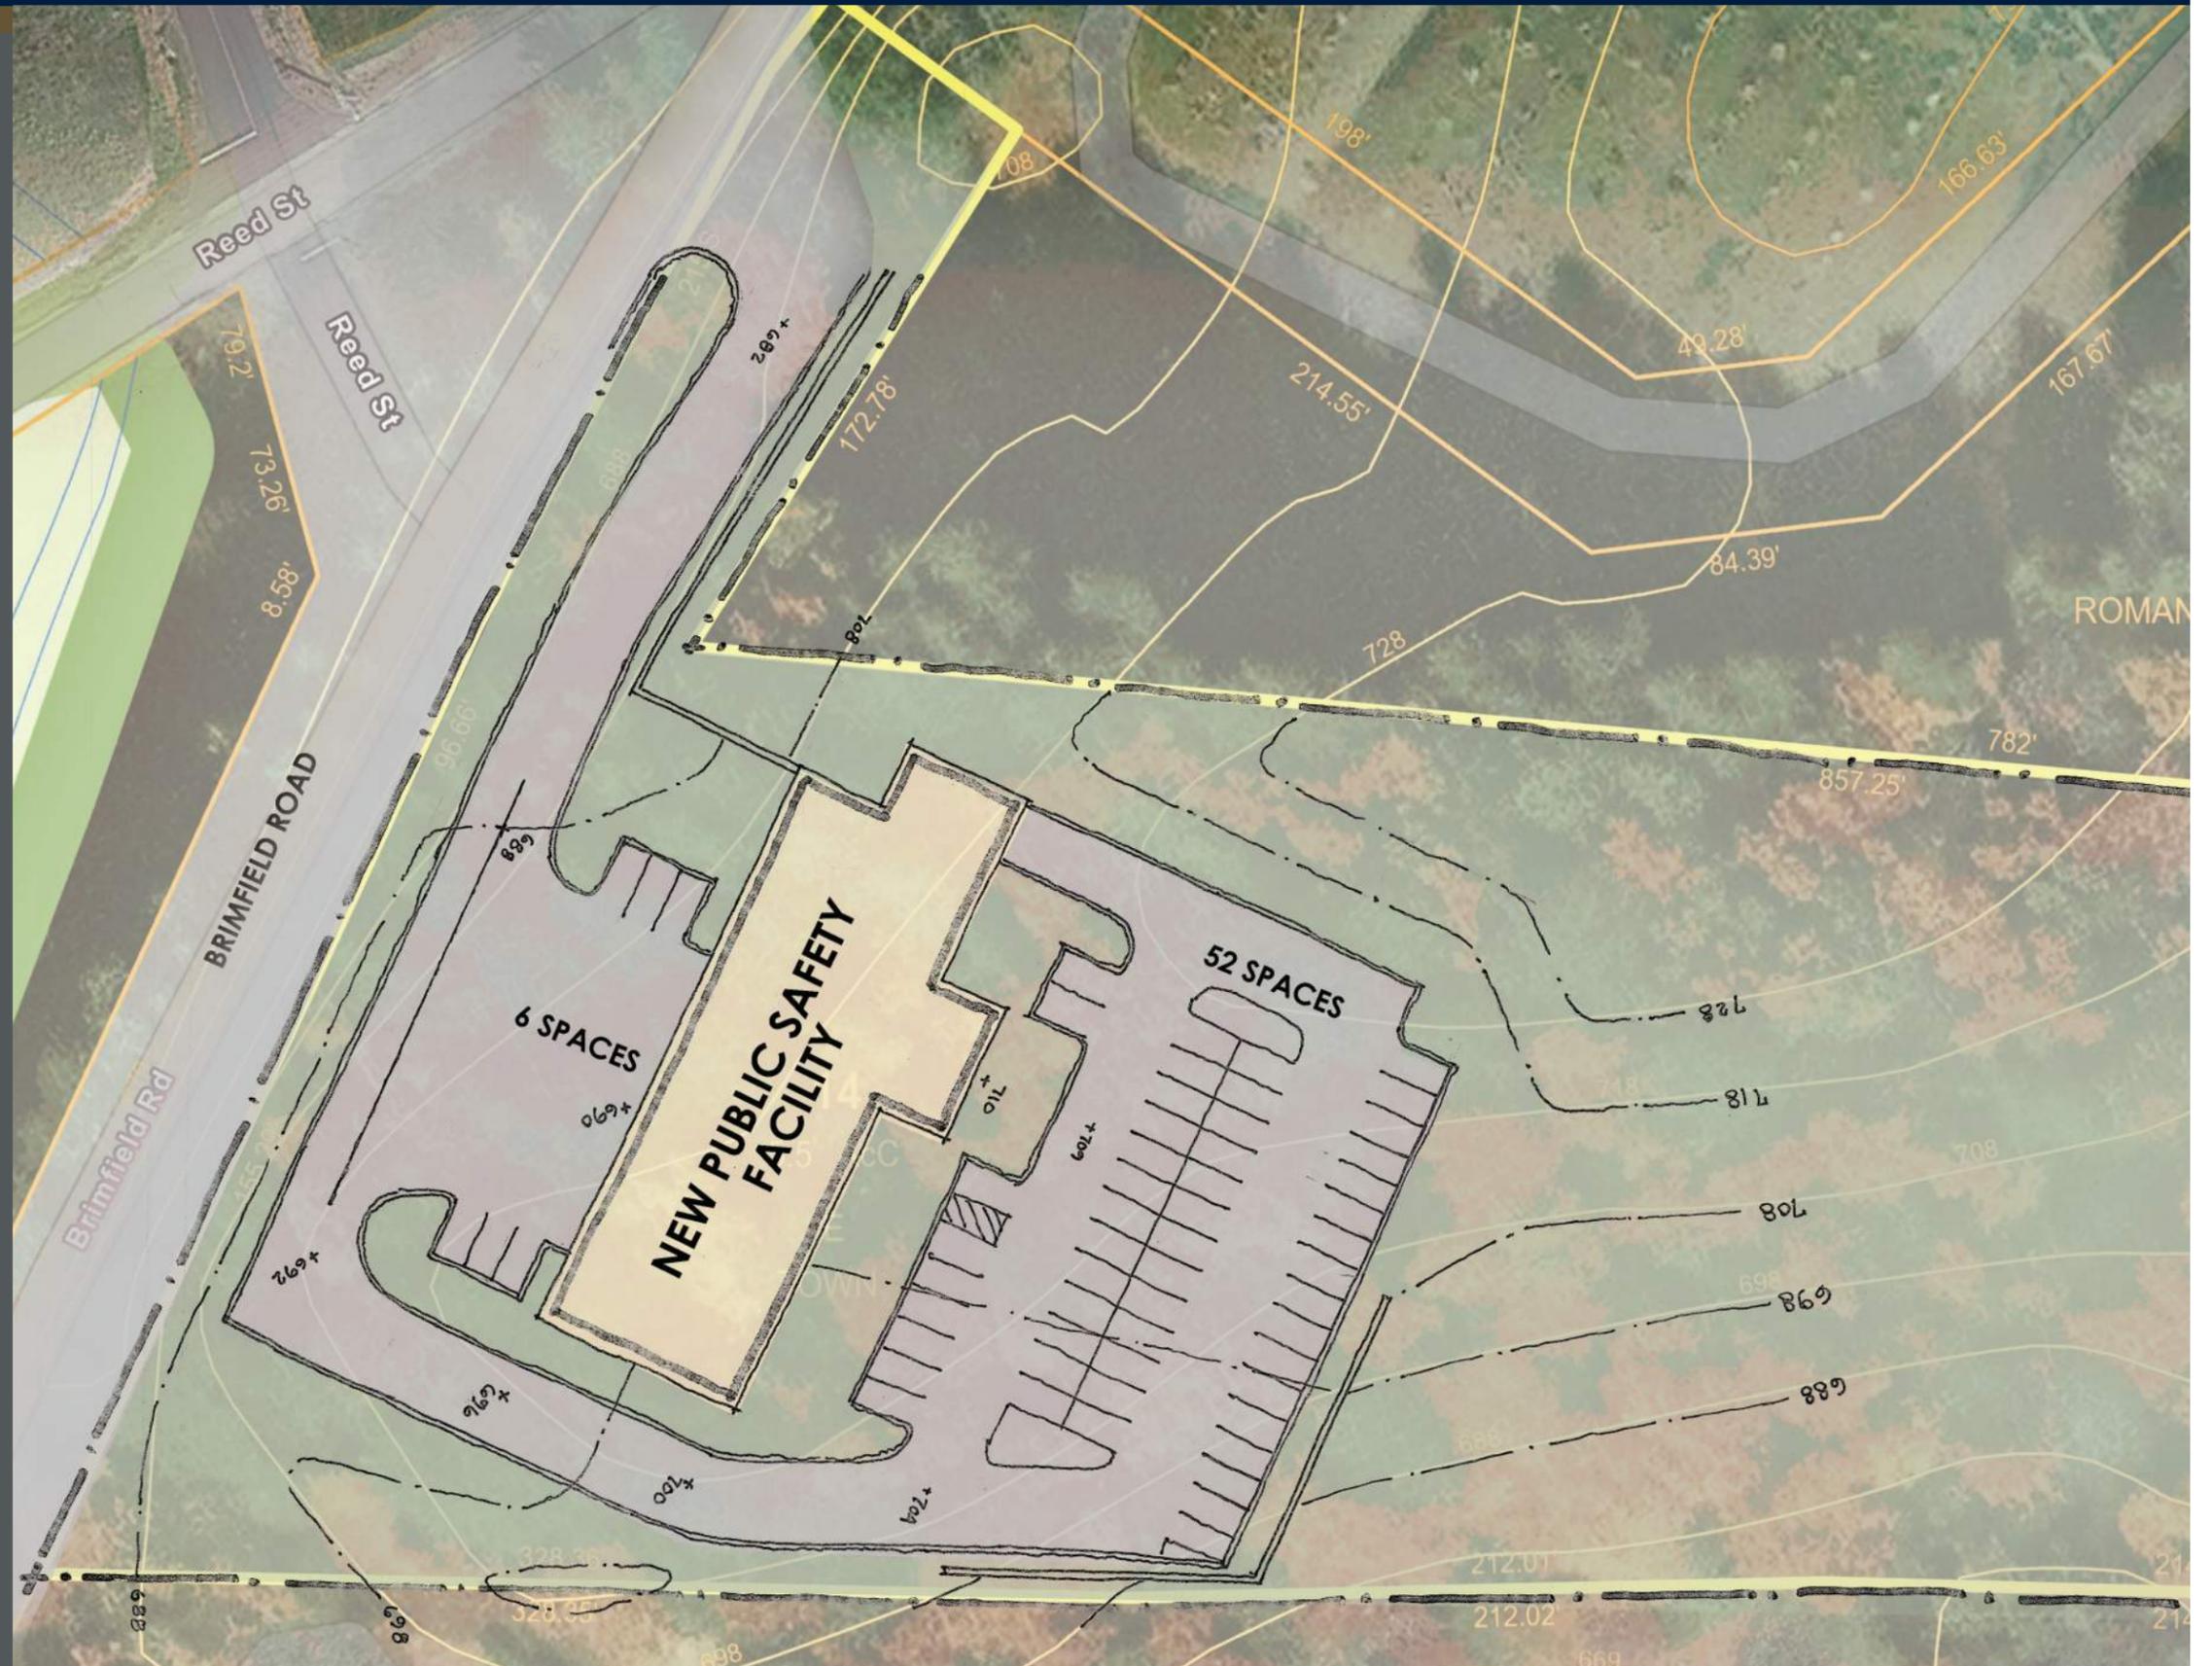
SITE TEST FIT - PARCEL 1 - OPTION A

This site is not viable as it does not provide for drive through bays.

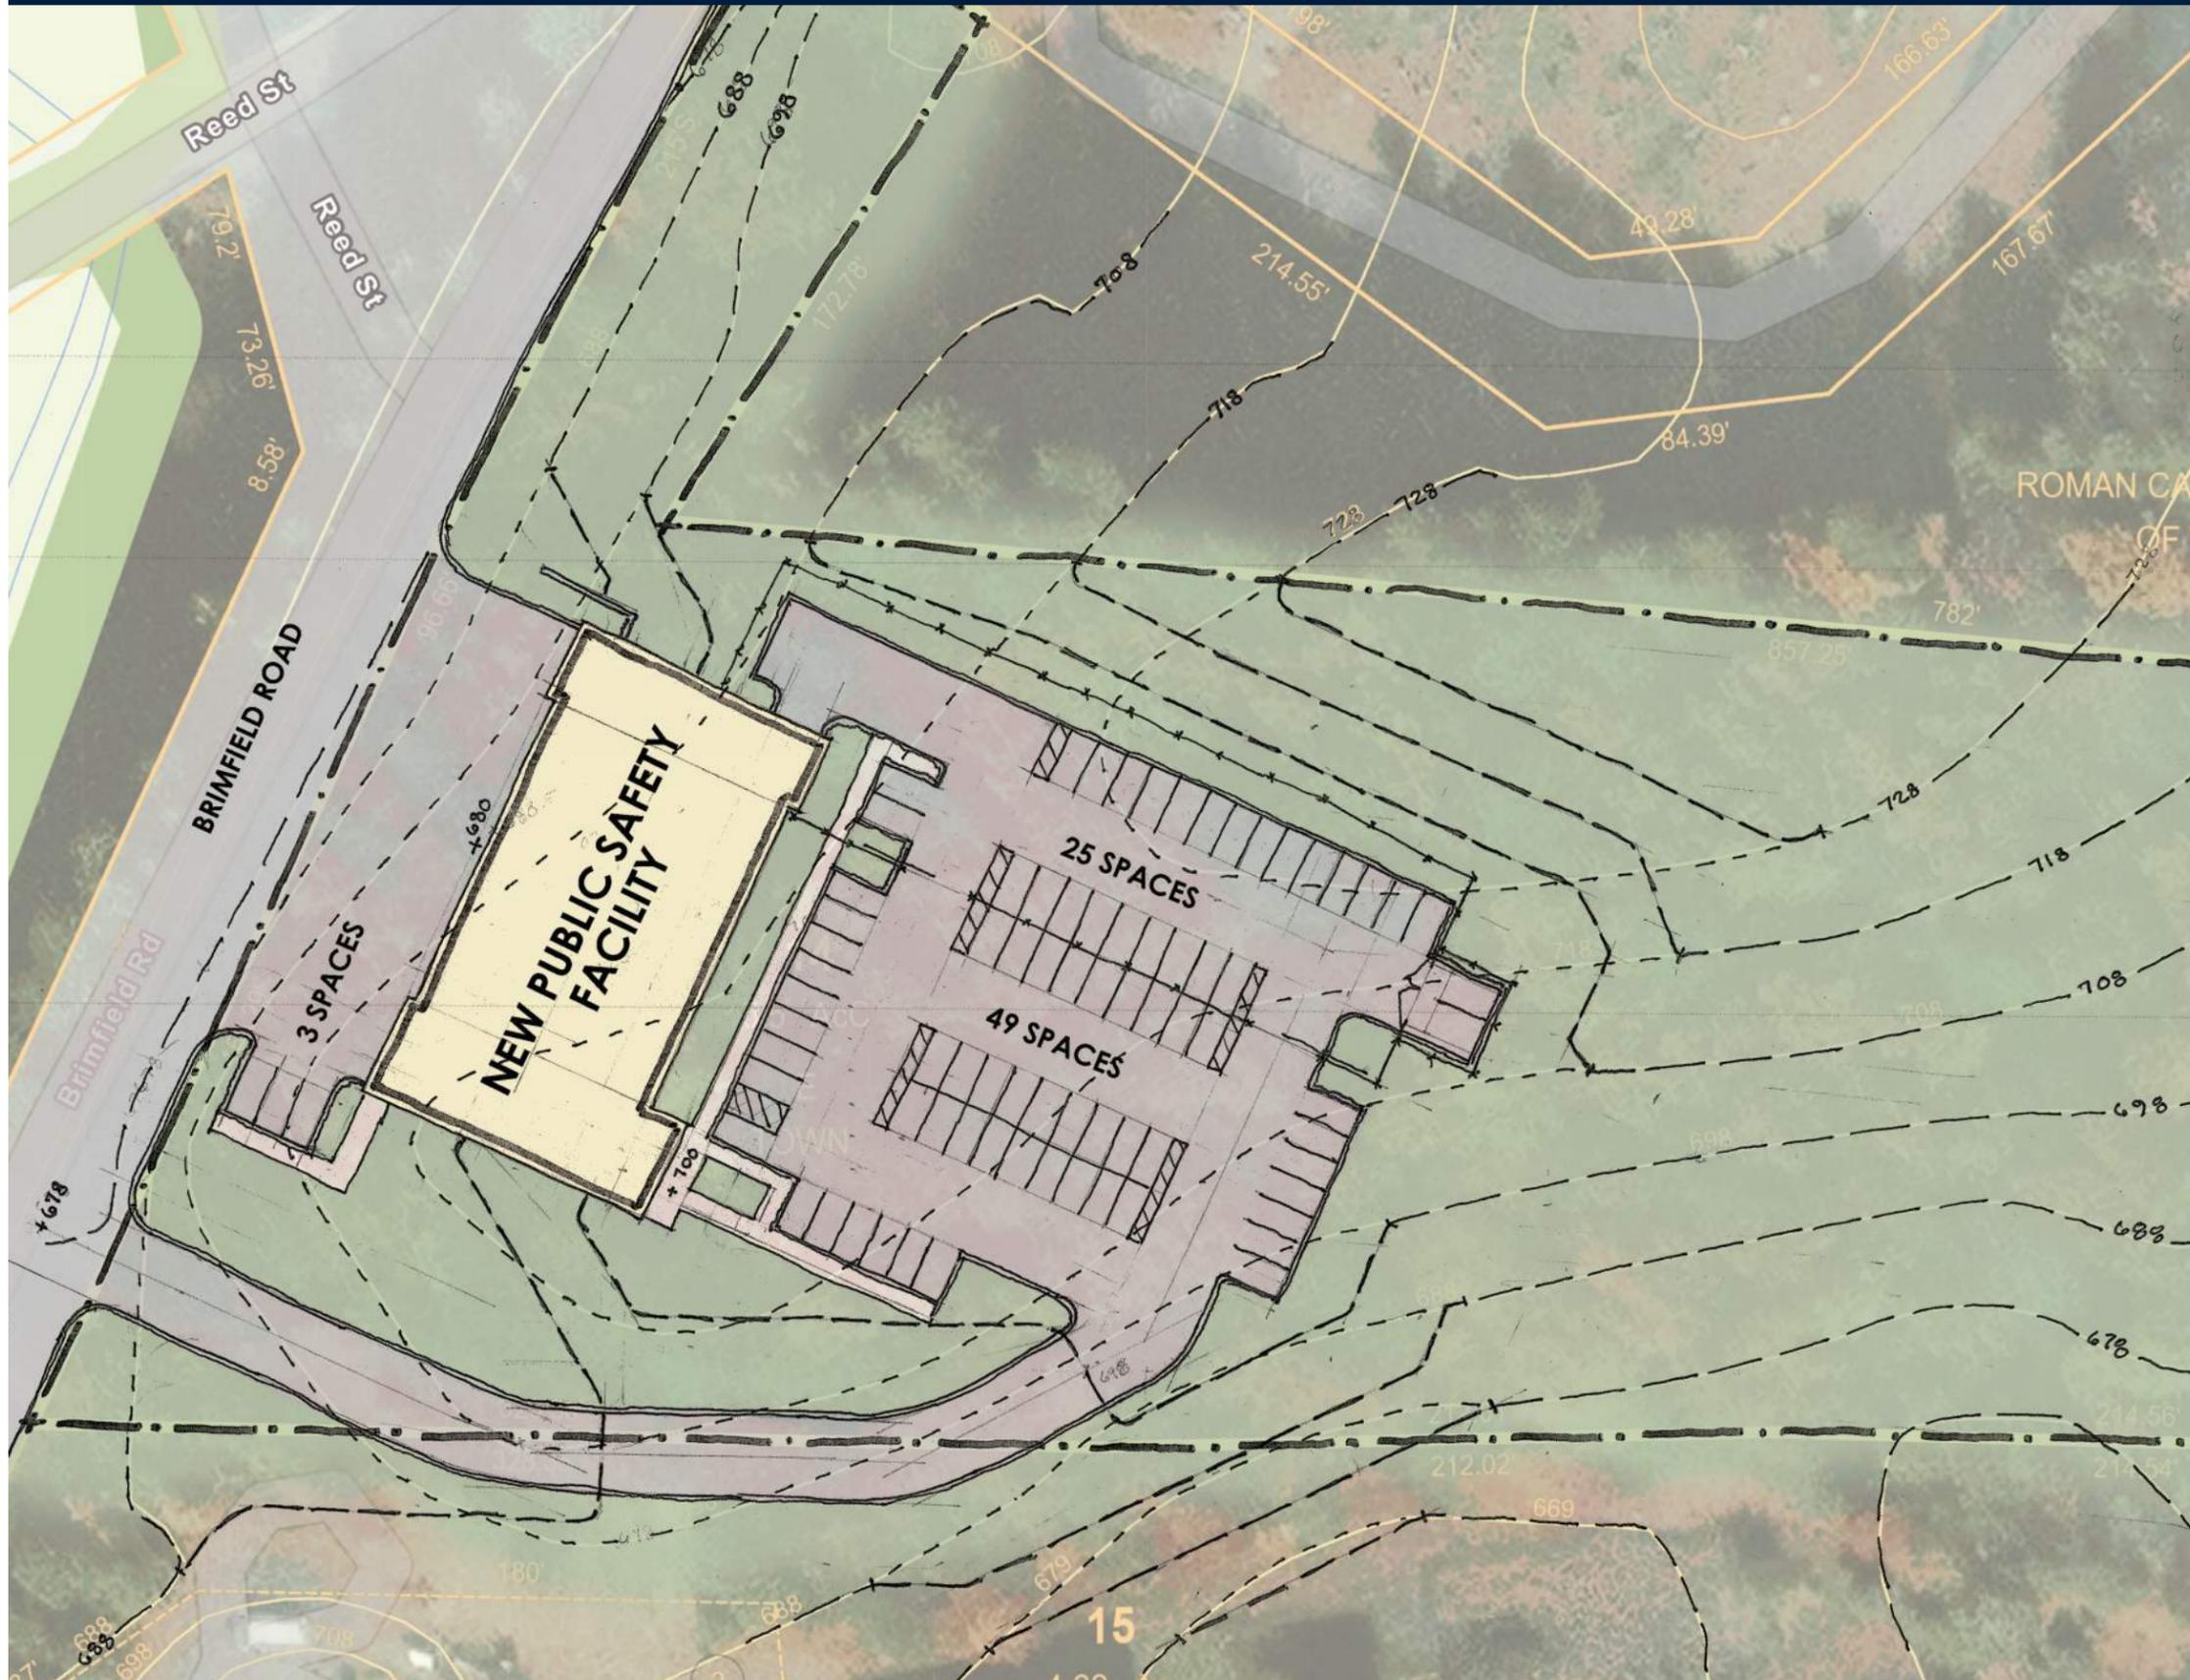
0 BRIMFIELD ROAD
Site ID 27-0-14

This test fit was an attempt to overcome some of the challenges presented in the prior test fit. Instead of pushing the building up the hill from Brimfield Road this solution carves out the site directly from the road. This allows for a properly sloped apron from the apparatus bays directly out the roadway avoiding slope issues and sharp turns. This solution still buries the back of the bays into the hill. Attempts to carve out the site enough to allow for drive through bays resulted in very significant and costly retaining walls, not to mention the expense of removing excess soil at prevailing wages. If earth removal could be accomplished through an agreement with private resources, it could create somewhat more favorable cost impact for excess soil removal. This solution did add an additional front-line bay to the apparatus room, again in an attempt to make the one-way bay more favorable. The Fire Department still prefers an outcome that includes drive through bays. This solution illustrates a total parking area more in alignment with the program and provides an opportunity to segregate secure parking within the overall lot. There is still limited parking adjacent to the bays for call fire fighters. The use of more retaining walls on the northern leg of the property could increase call parking, but at a cost. It was necessary to manage the slope on the access driveway to the rear parking lot, so it does extend across the property line with the DPW Garage. Since this is common ownership, it should not be a problem.

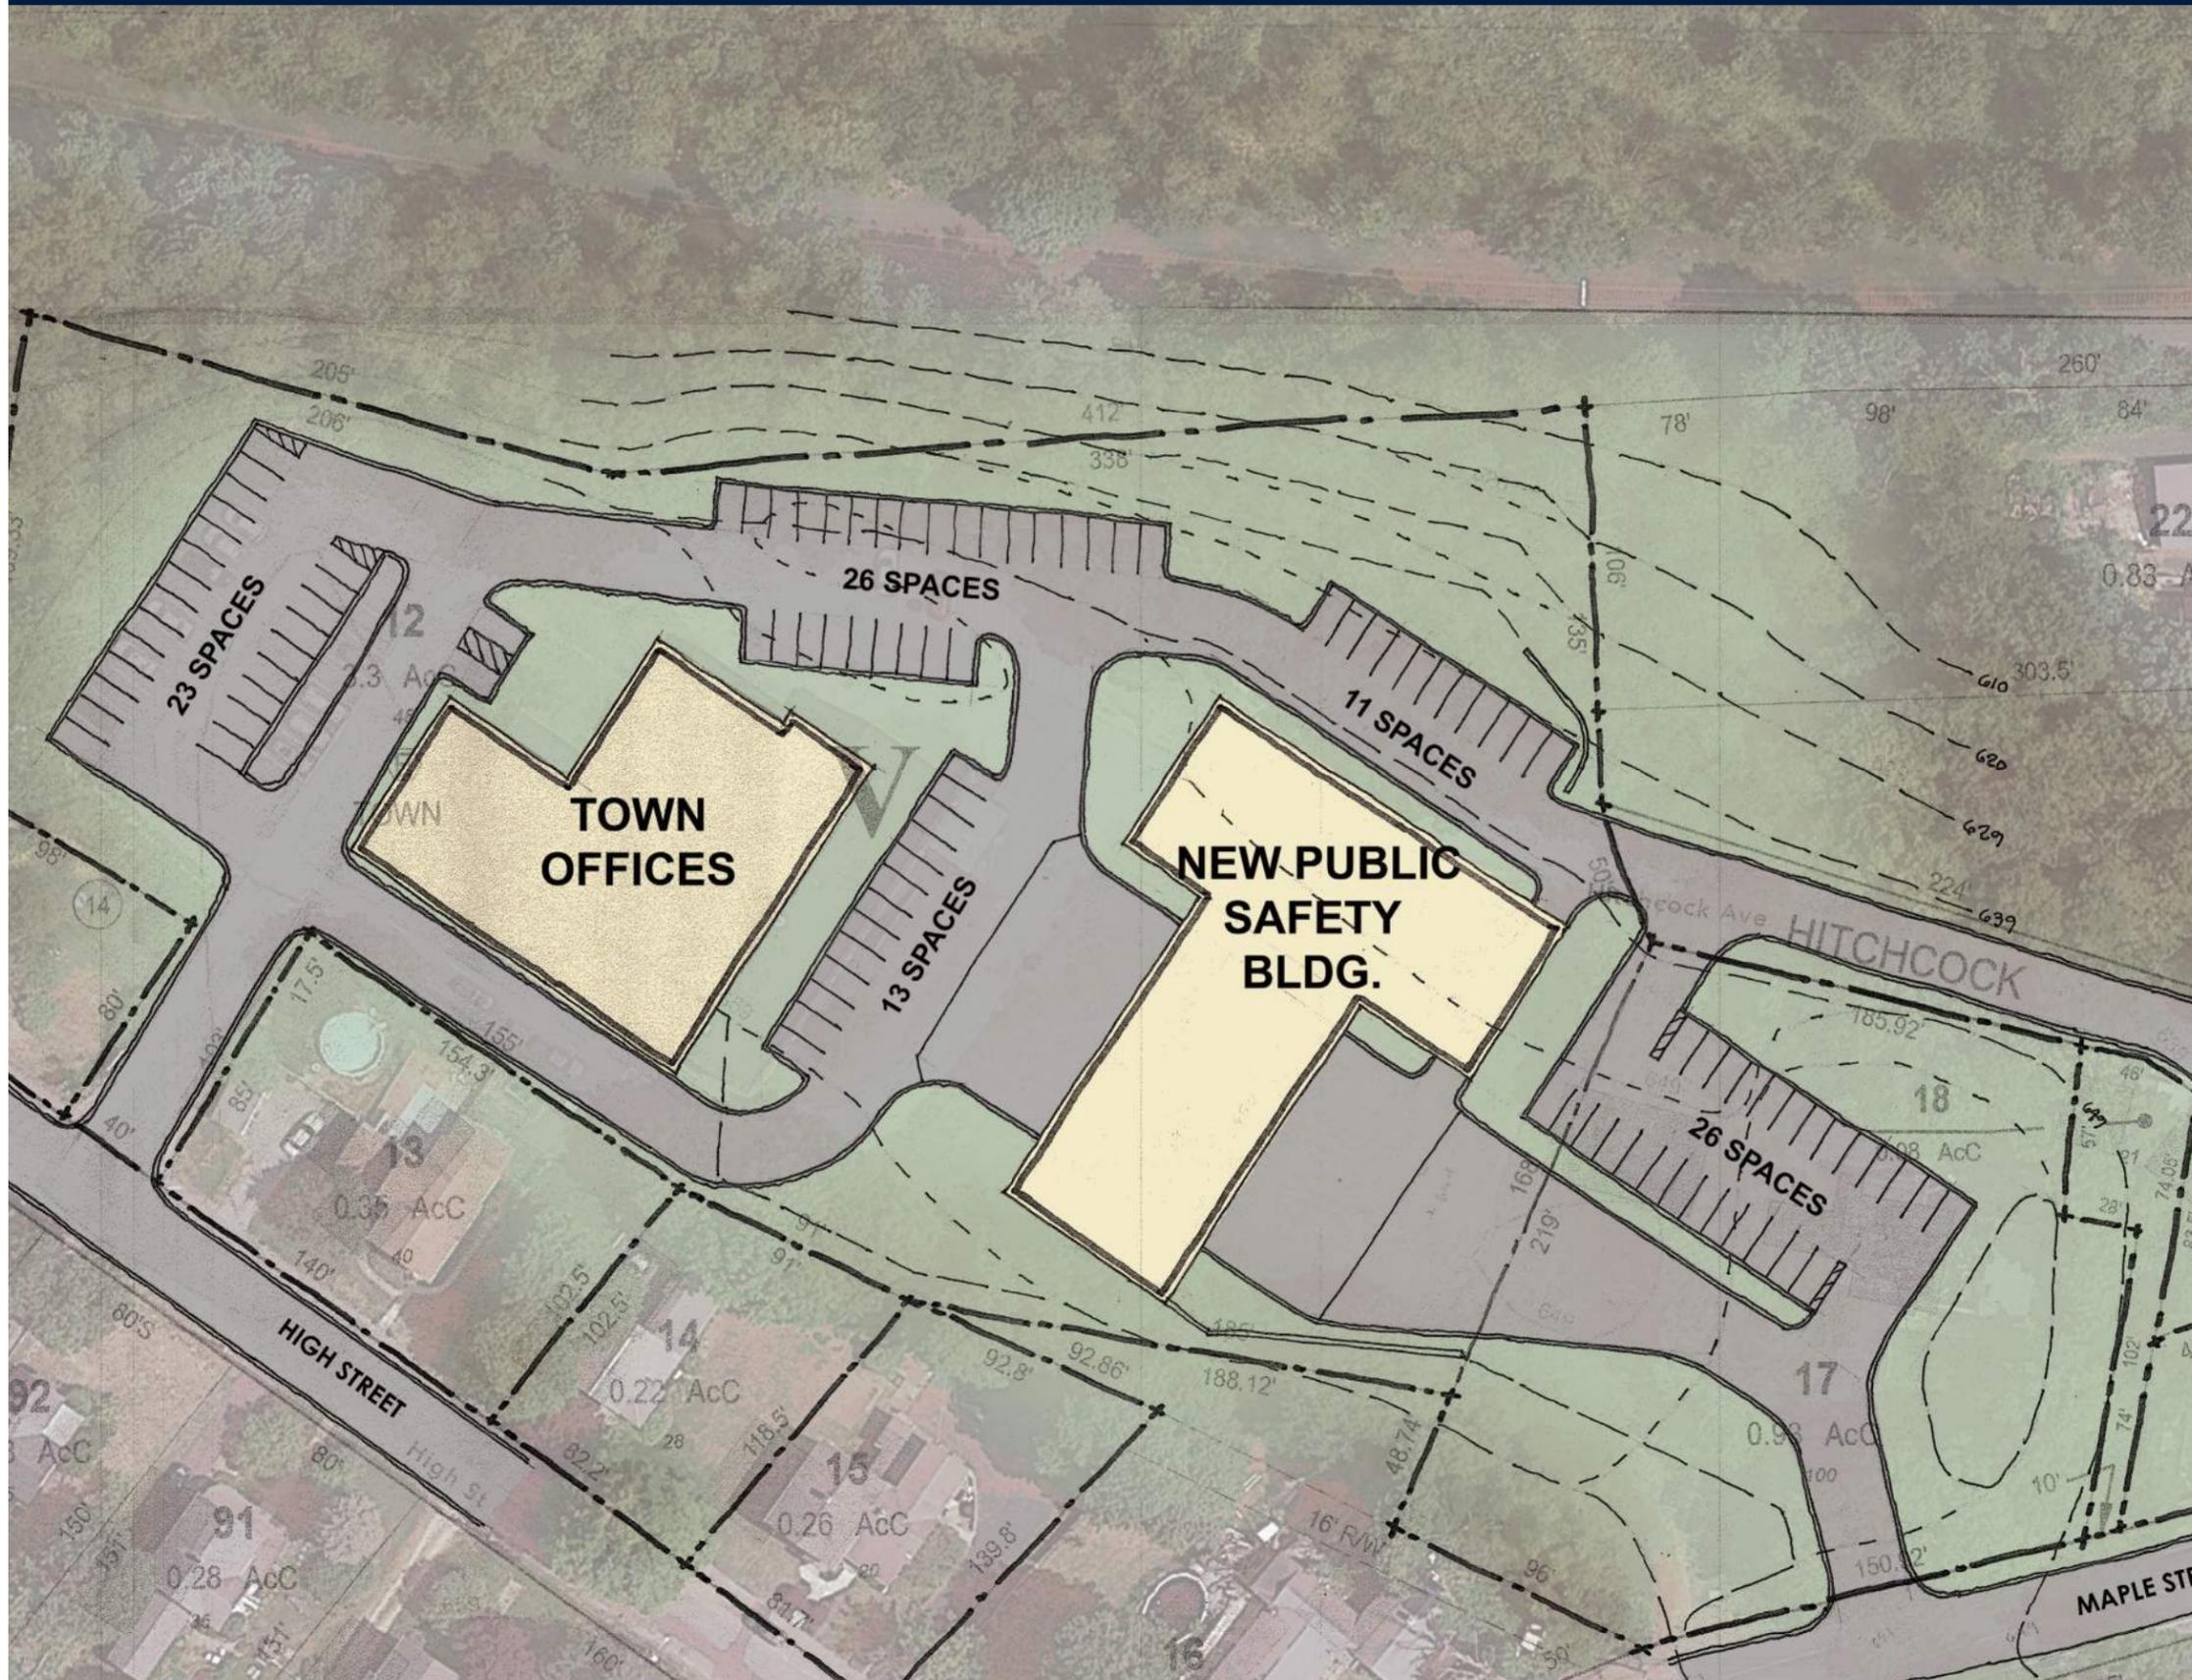
This site is viable with consideration to the slope concerns on Maple Street.

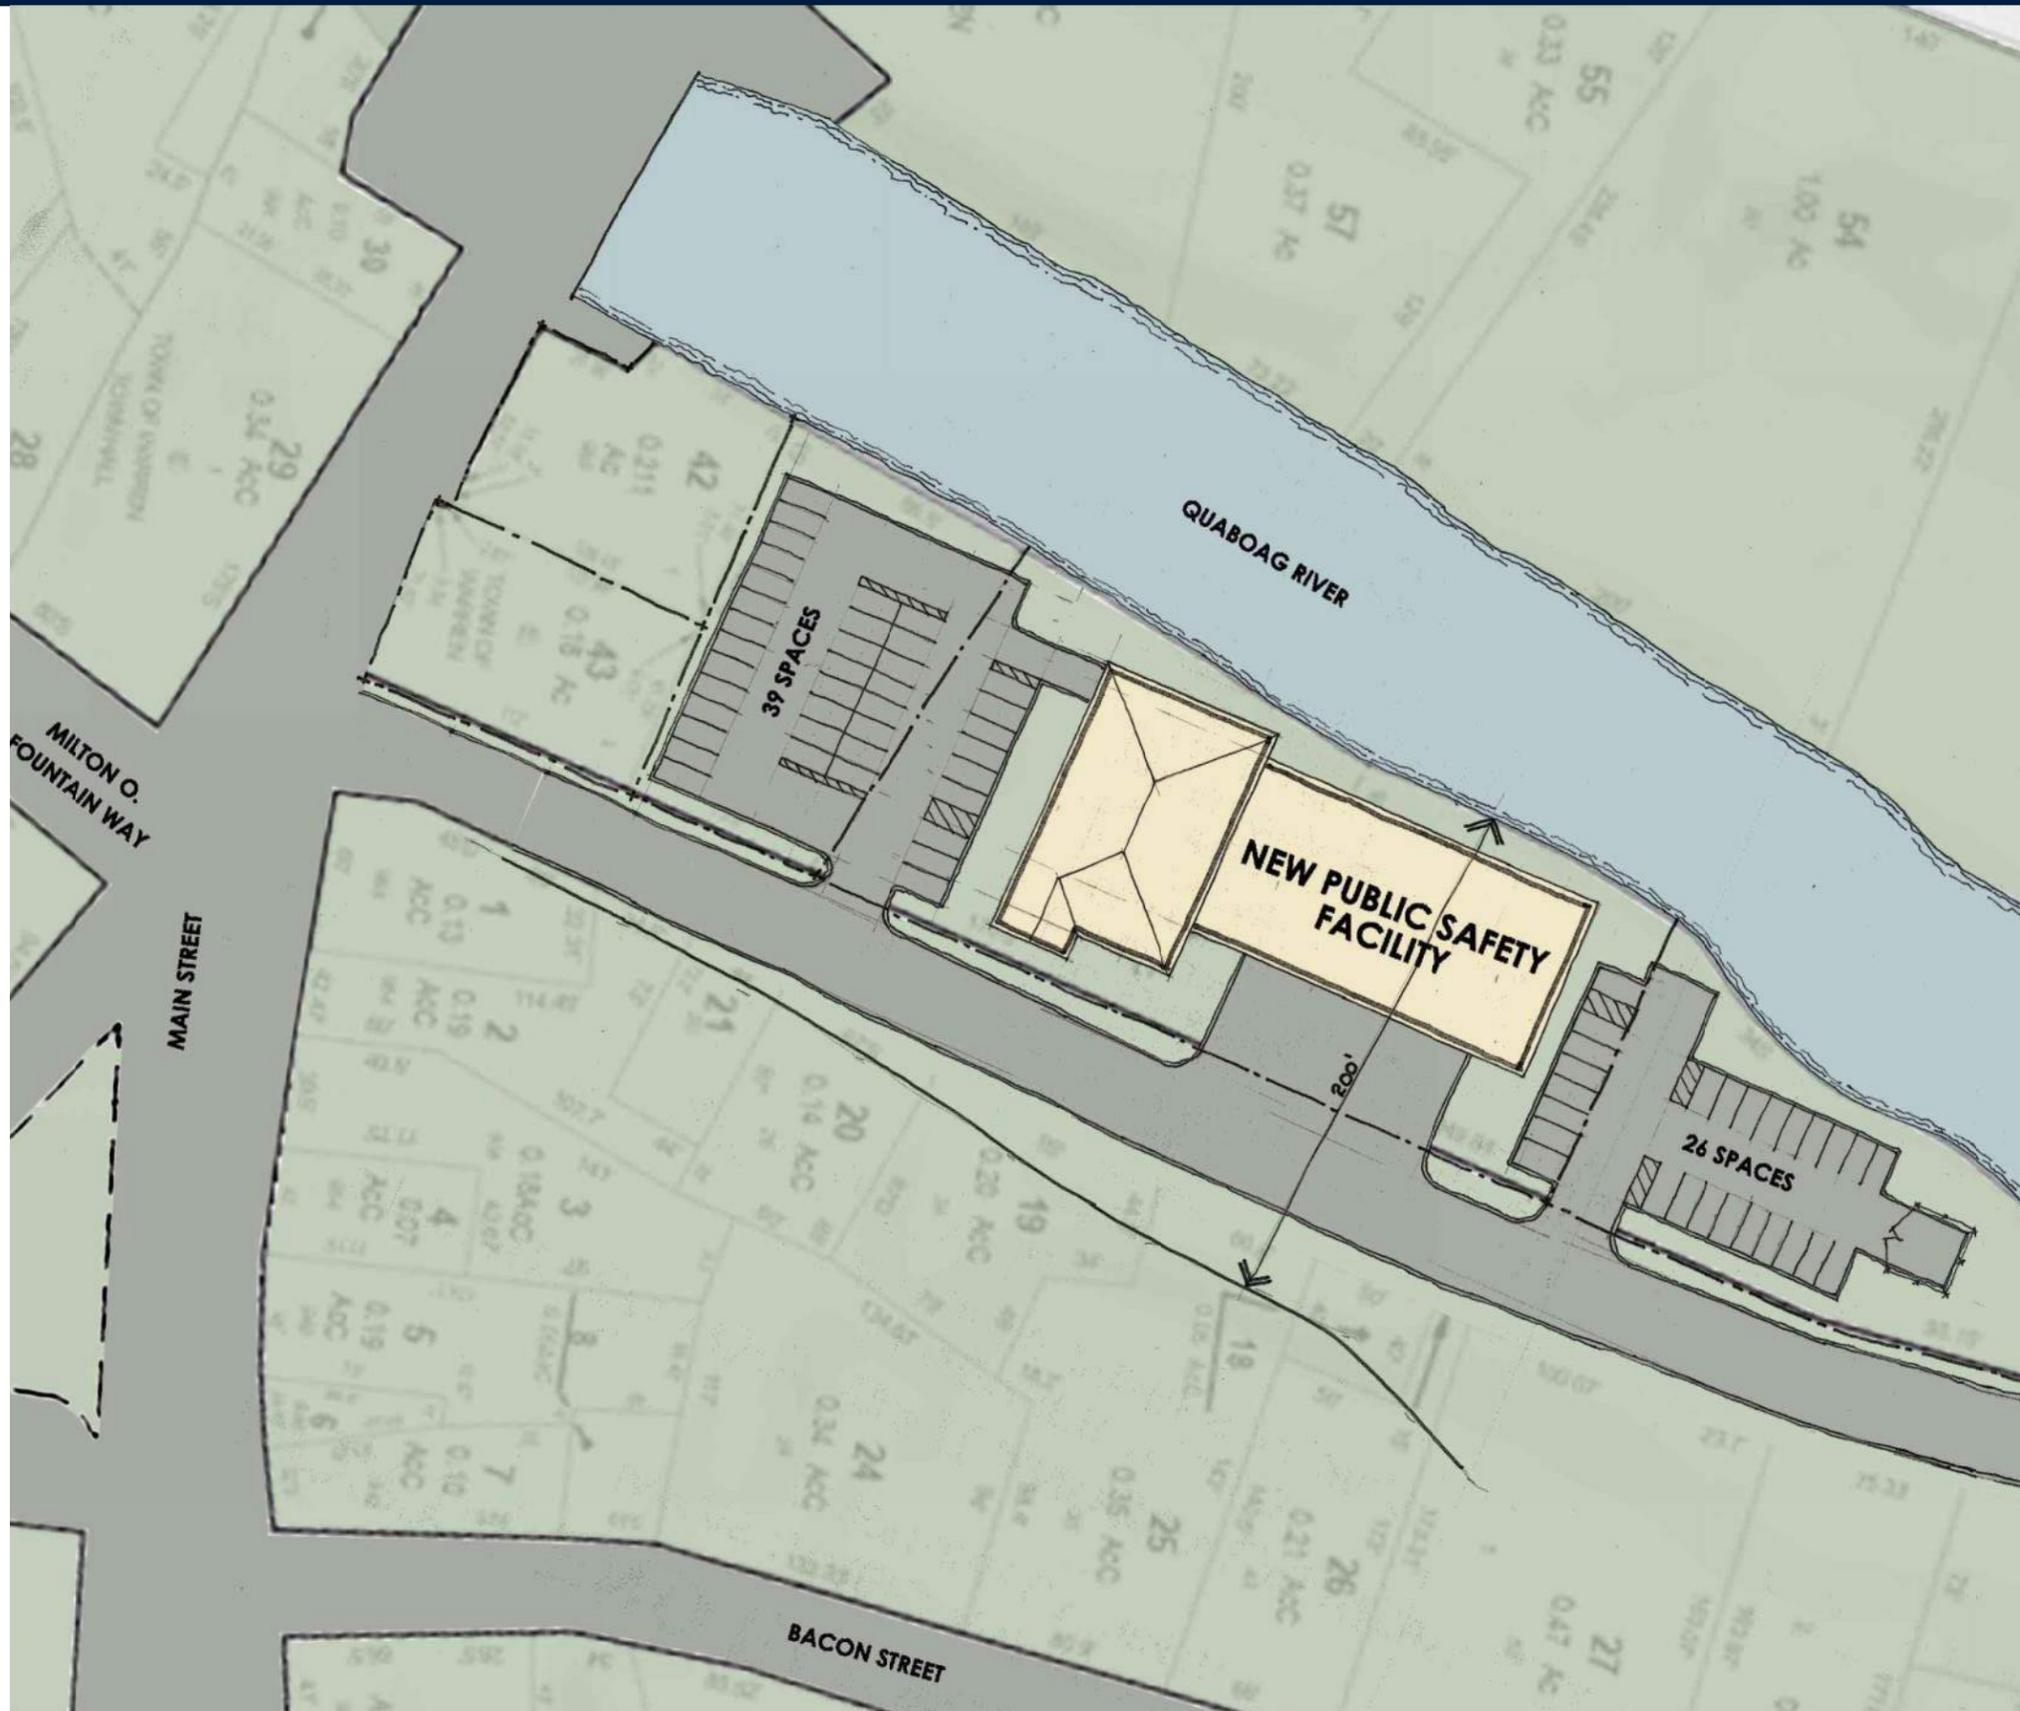
0 OLD WEST BROOKFIELD ROAD
Parcel # 18-0-7, 18-0-8, 18-0-9

This combination of parcels once housed a dry-cleaning operation, which has been reduced to the concrete pad only. The site is entirely located within the 200' riverfront protection zone of the Quaboag River, which means that development beyond previously disturbed areas, particularly right along the waterfront, will be restricted. As the test fit illustrates a two-story building beside a one-story apparatus bay, along with the needed parking causes development over almost the entire property. Further the rear of the building is in very close proximity to the river's edge. This test fit is likely to face significant approval hurdles and may not be approved. In addition, the site does not permit a drive through apparatus bay. A requirement that the Fire Department has stated is a critical requirement.

This site is not viable as it has approval challenges and does not provide drive through bays.

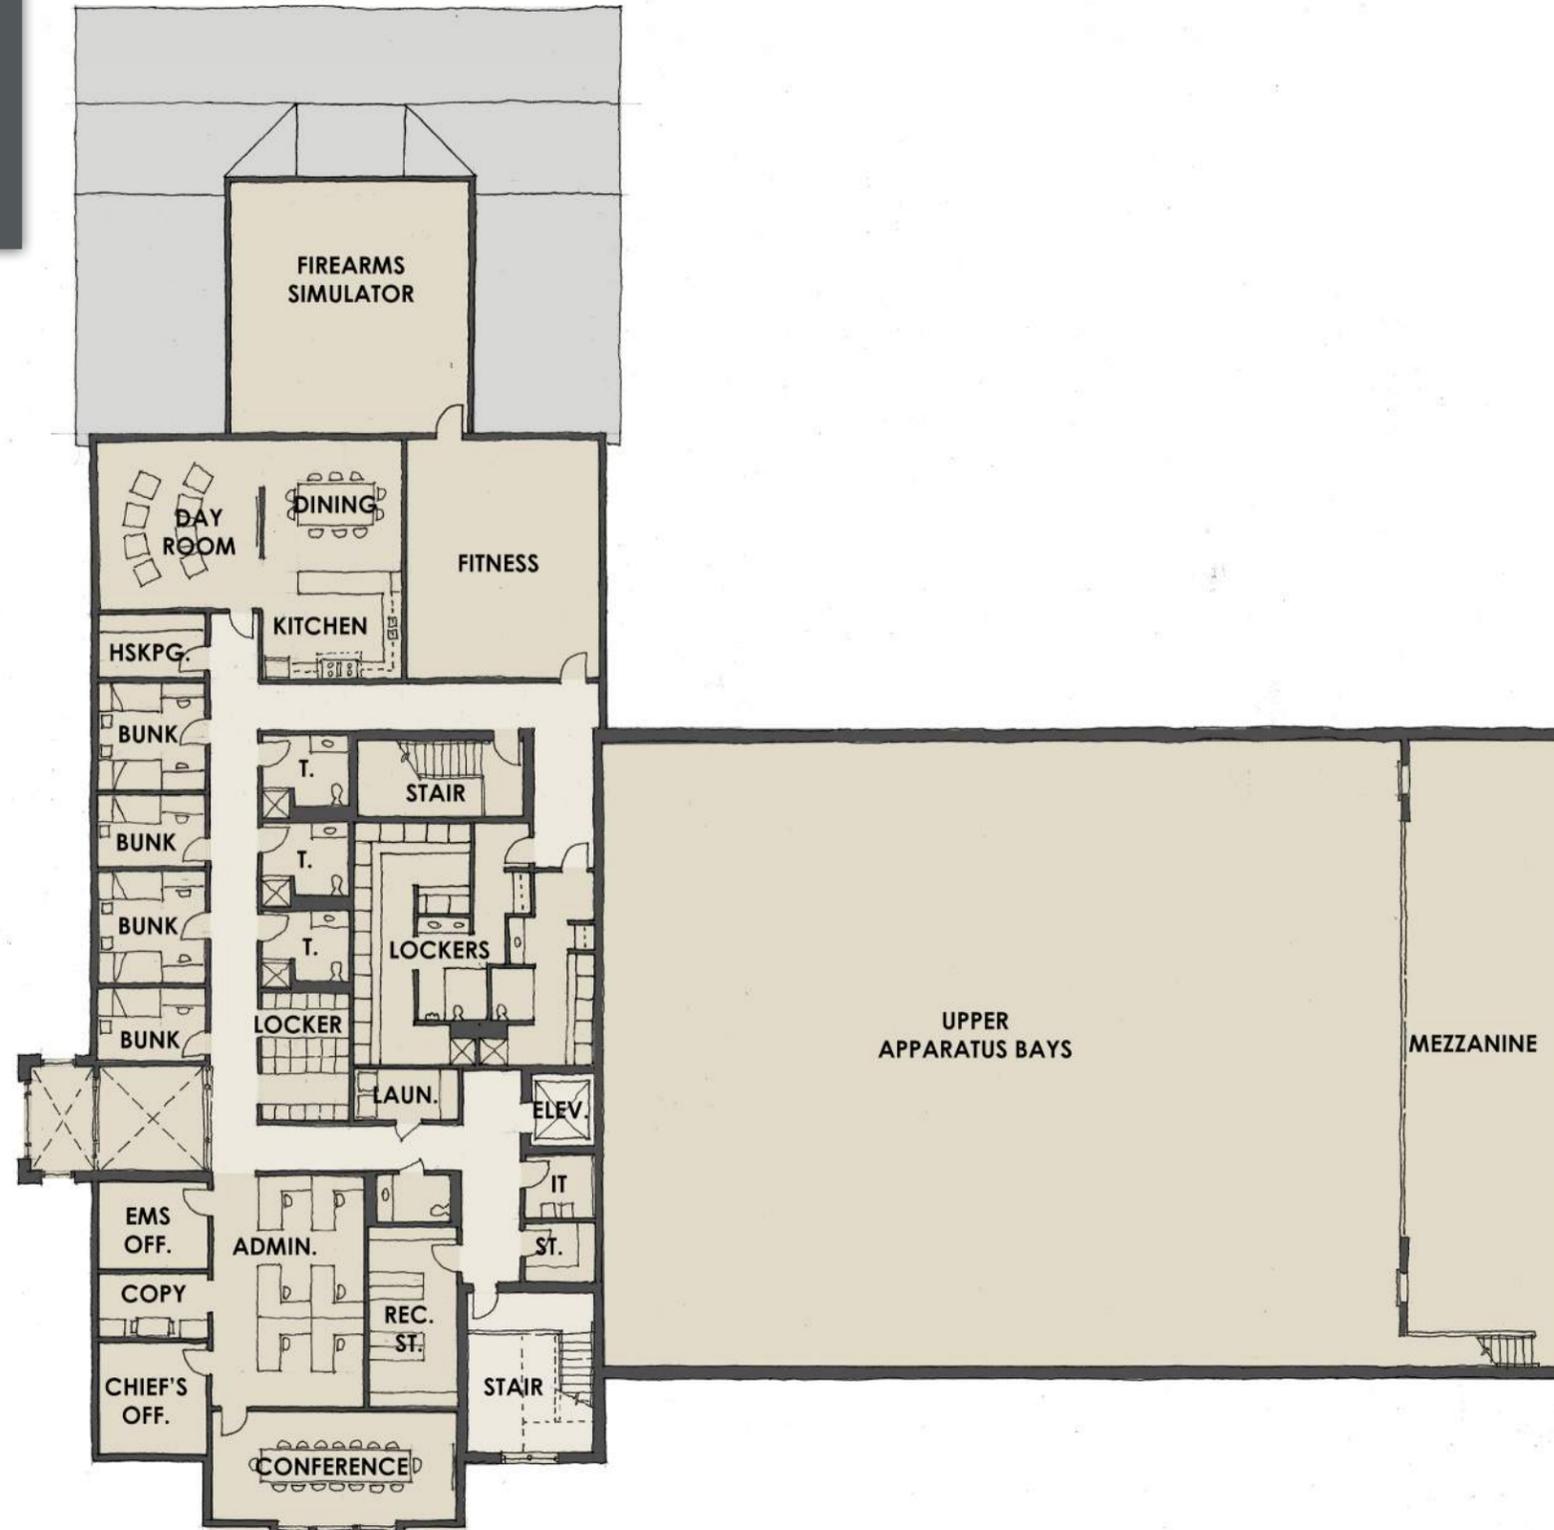
The fitness, firearms training simulator and kitchen are located upstairs, near the stair from the Police Department, and proximate to the Police locker rooms. Both stairs feed down both to the apparatus bays and to the building exterior, allowing quick response for the Fire Department. Apparatus support spaces are located on the sides of the bays, with areas servicing the call fire fighters located near the call fire fighter parking lot. The Police Department prisoner areas and sally port are to the rear of the building near an exterior door to serve for prisoner release.

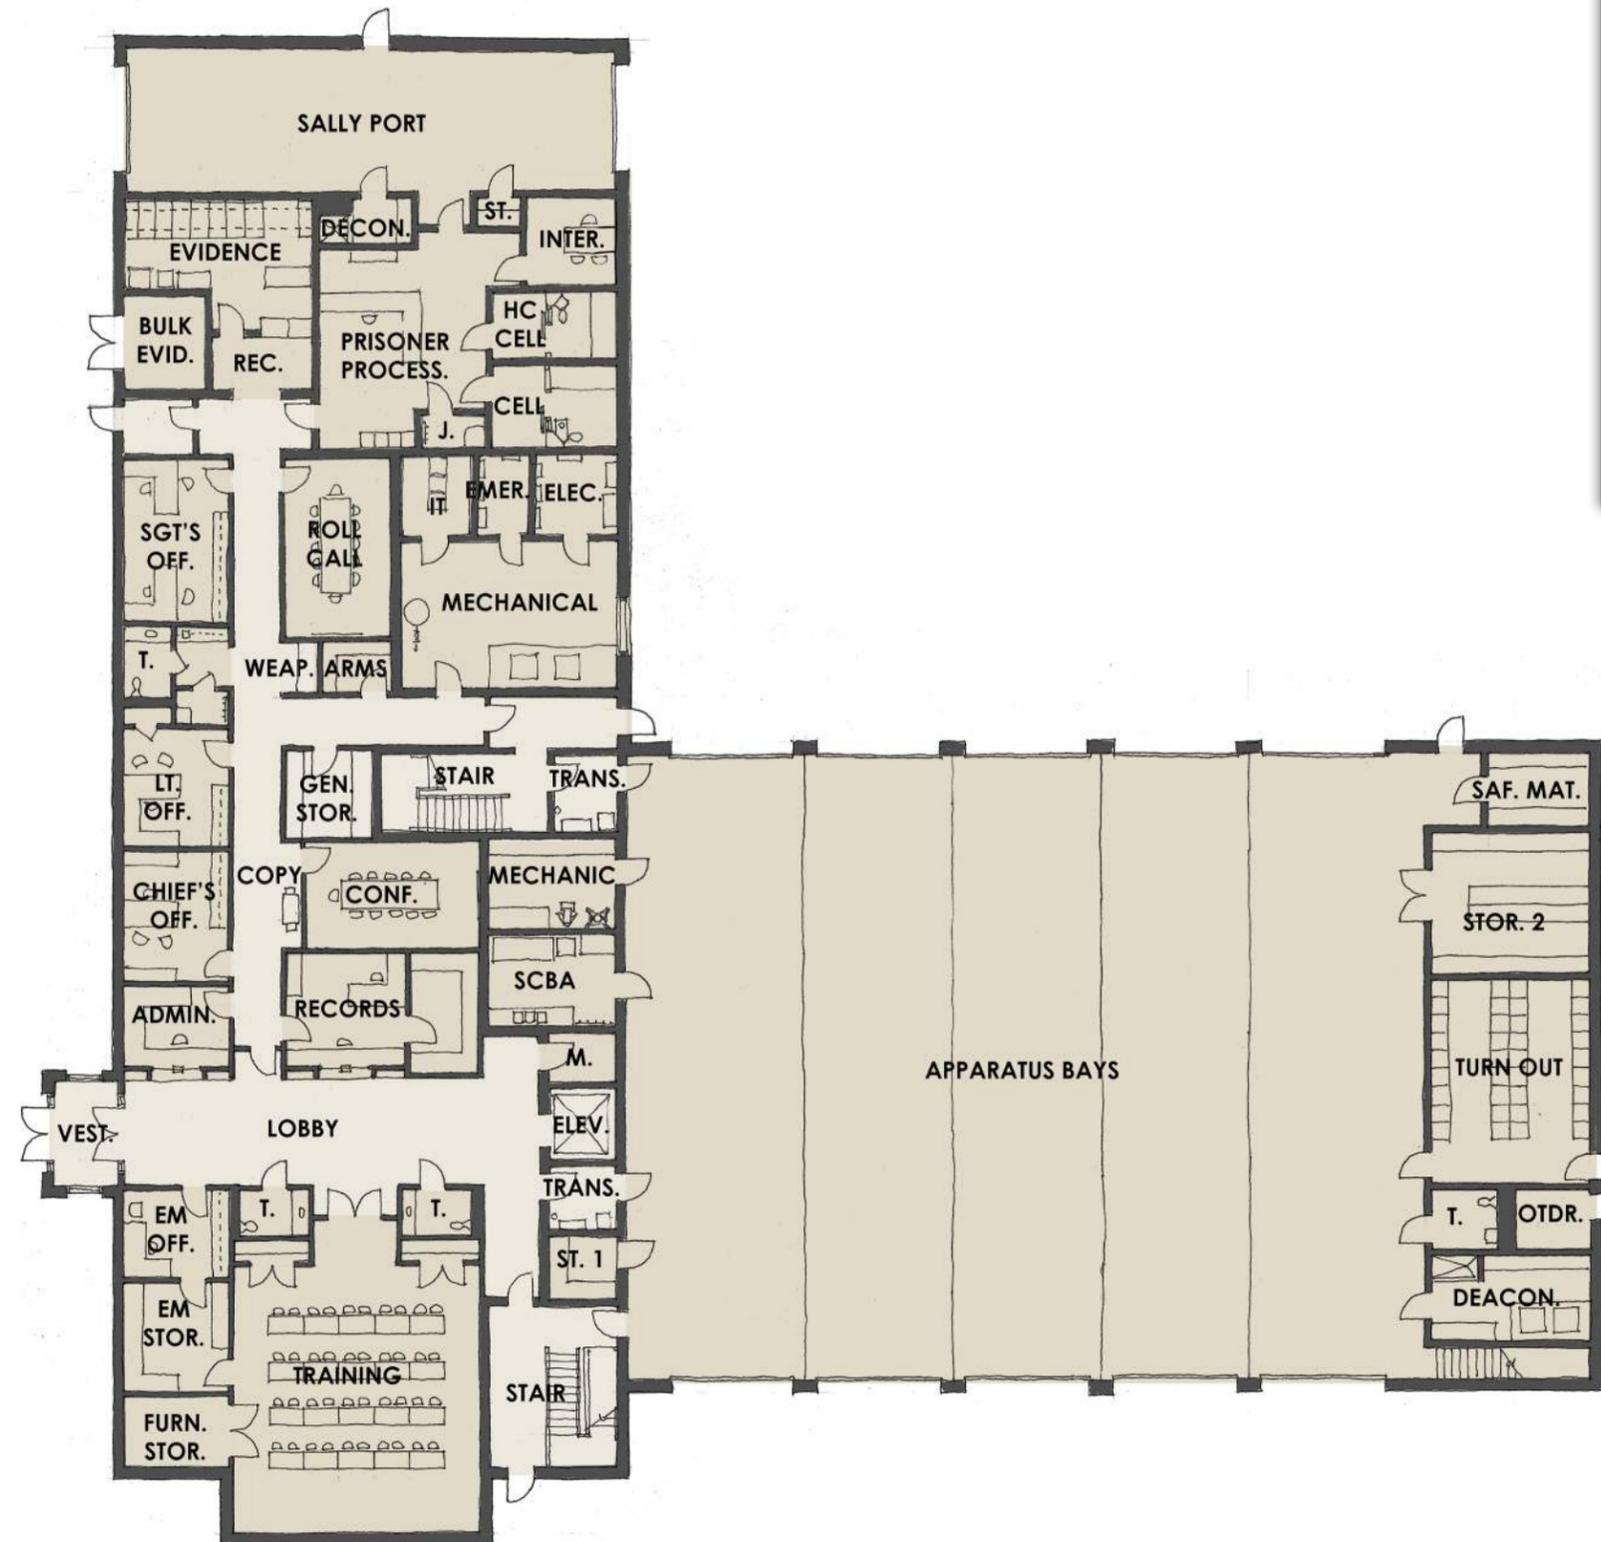
CONCEPTUAL FLOOR PLAN DESIGN

The floor plan for this site is the same as the Brimfield Road site except that the Sally Port orientation has been adjusted to allow for site grading considerations. Instead of a single, double deep, drive through bay, this plan uses side by side double bay with a drive-in, back-out configuration. The building has a two-story component which houses the police functions on the ground floor and the fire department functions on the upper floor. Shared functions such as the training room, fitness room and kitchen are located for easy access by both departments. The training room is just off the main lobby which means it can be used for either department, for hosting outside department joint training, or even for department meetings with the community.

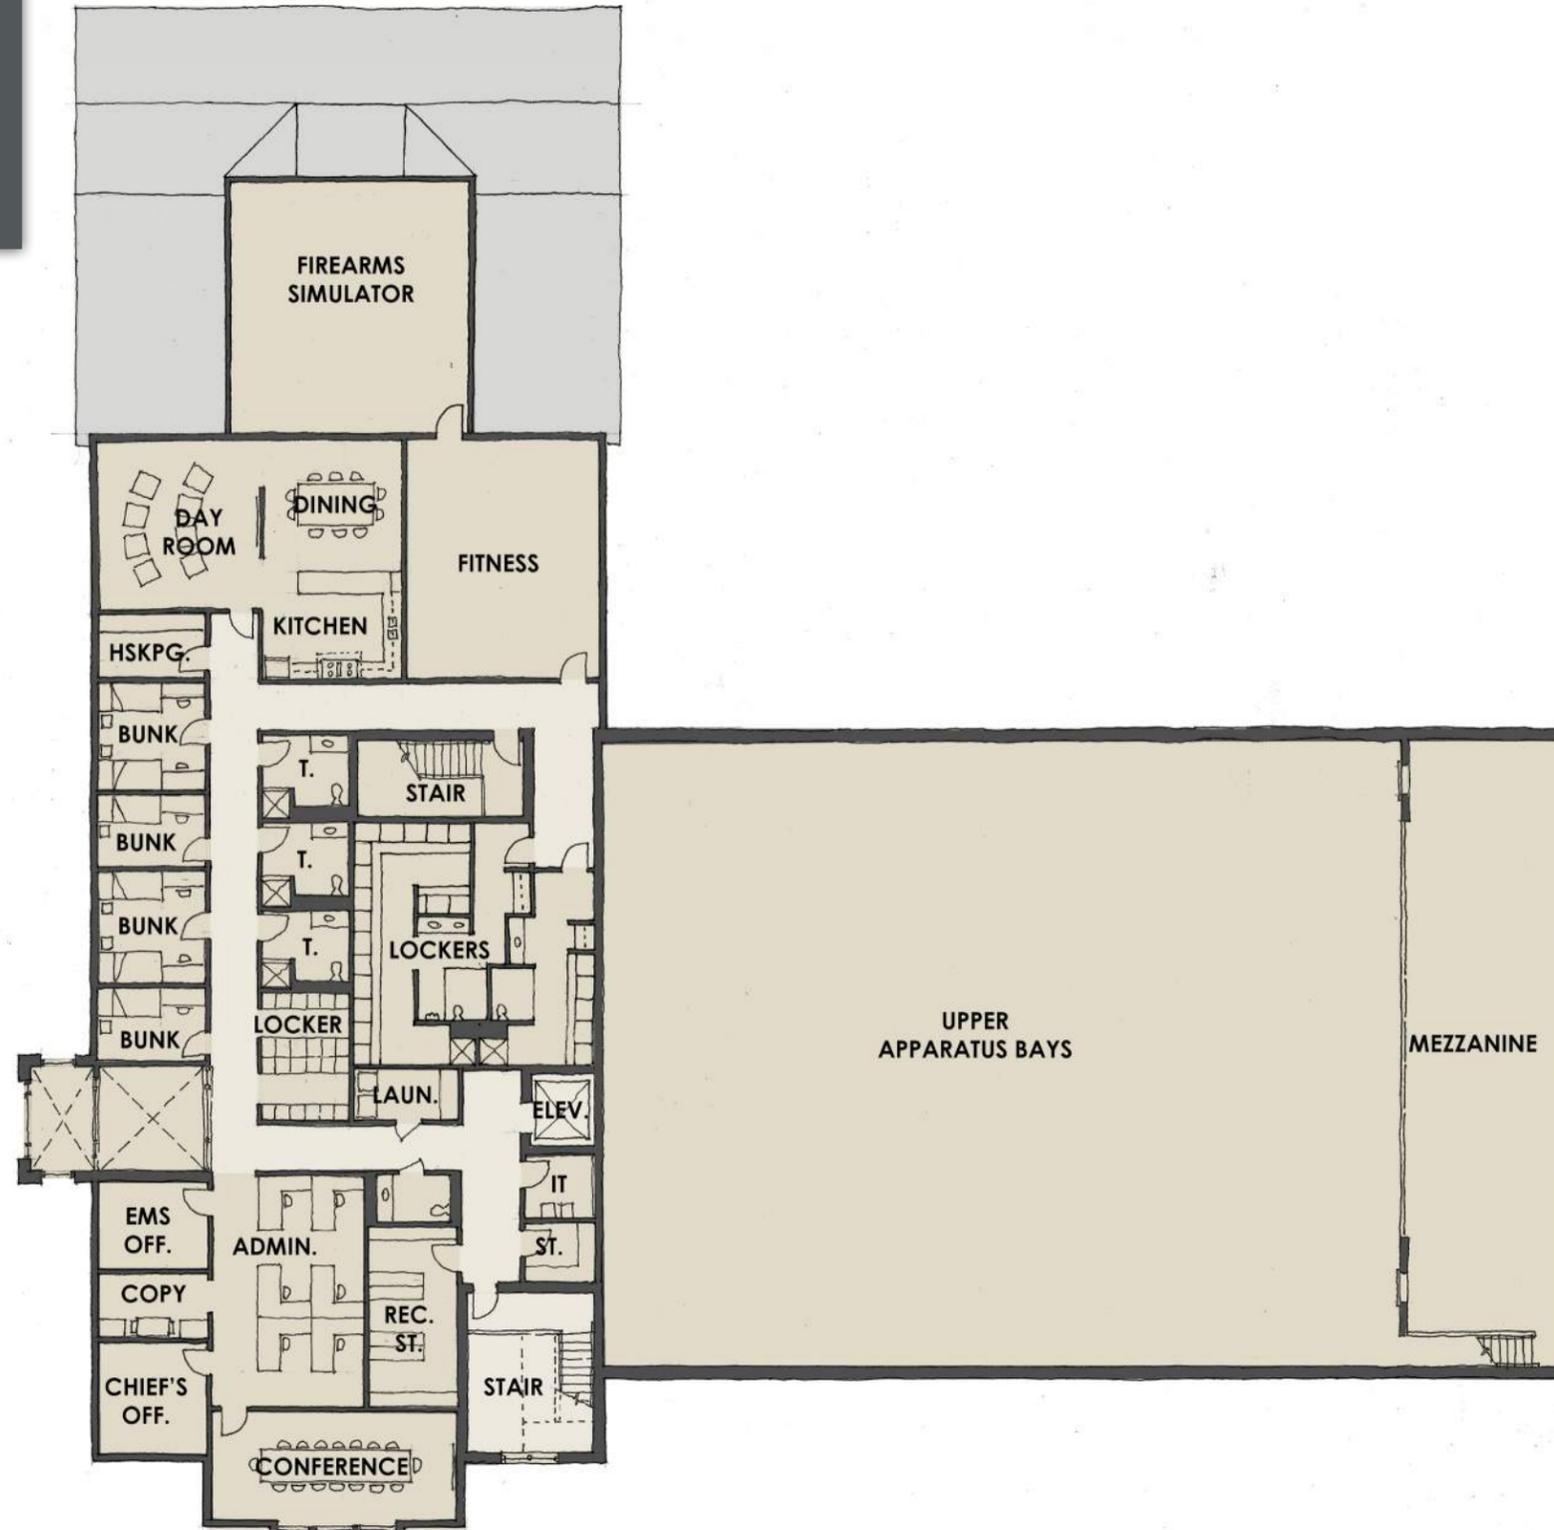
The fitness and kitchen are located upstairs, near the stair from the Police Department, and proximate to the Police locker rooms. Both stairs feed down both to the apparatus bays and to the building exterior allowing quick response for the Fire Department. Apparatus support spaces are located on the sides of the bays, with areas servicing call fire fighters located near the call fire fighter parking lot. The Police Department prisoner areas and sally port are to the rear of the building near an exterior door to serve for prisoner release.
