WARREN PUBLIC SAFETY COMPLEX FEASIBILITY STUDY

TOWN OF WARREN, MASSACHUSETTS

ISSUED: OCTOBER 2024

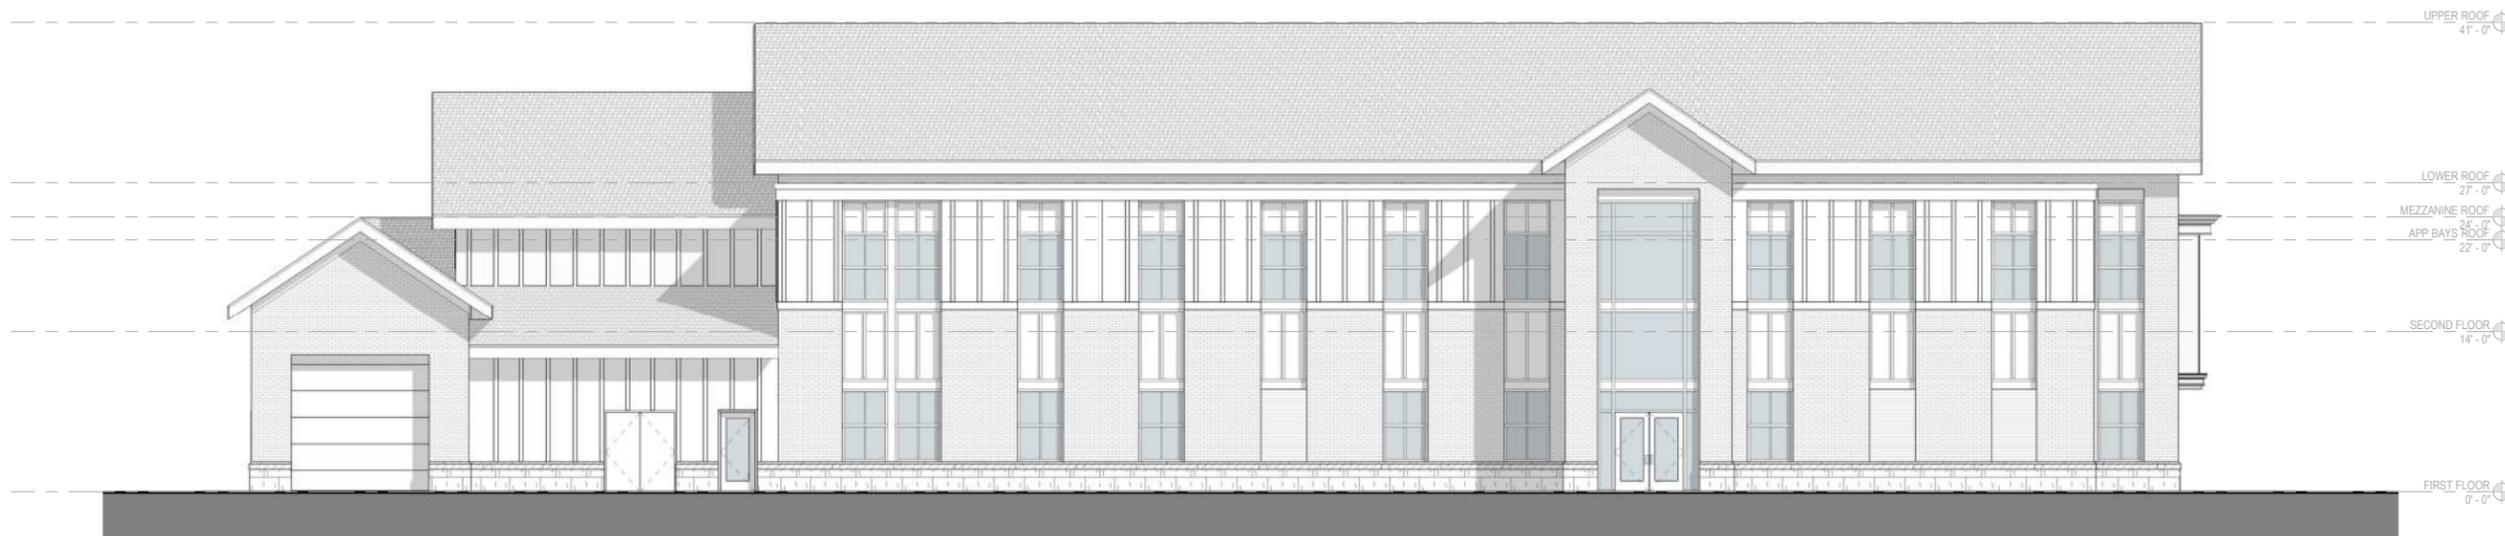
NORTH ELEVATION

The building exterior uses a combination of masonry, cementitious siding, and some metal siding. The two-story mass of the building will be of conventional wood frame construction, while the apparatus bays will use a pre-engineered steel frame, with a combination of masonry and metal siding. The design uses traditional materials and volumes to reflect the character of the community but employs some more contemporary details to demonstrate this is a modern public safety facility.

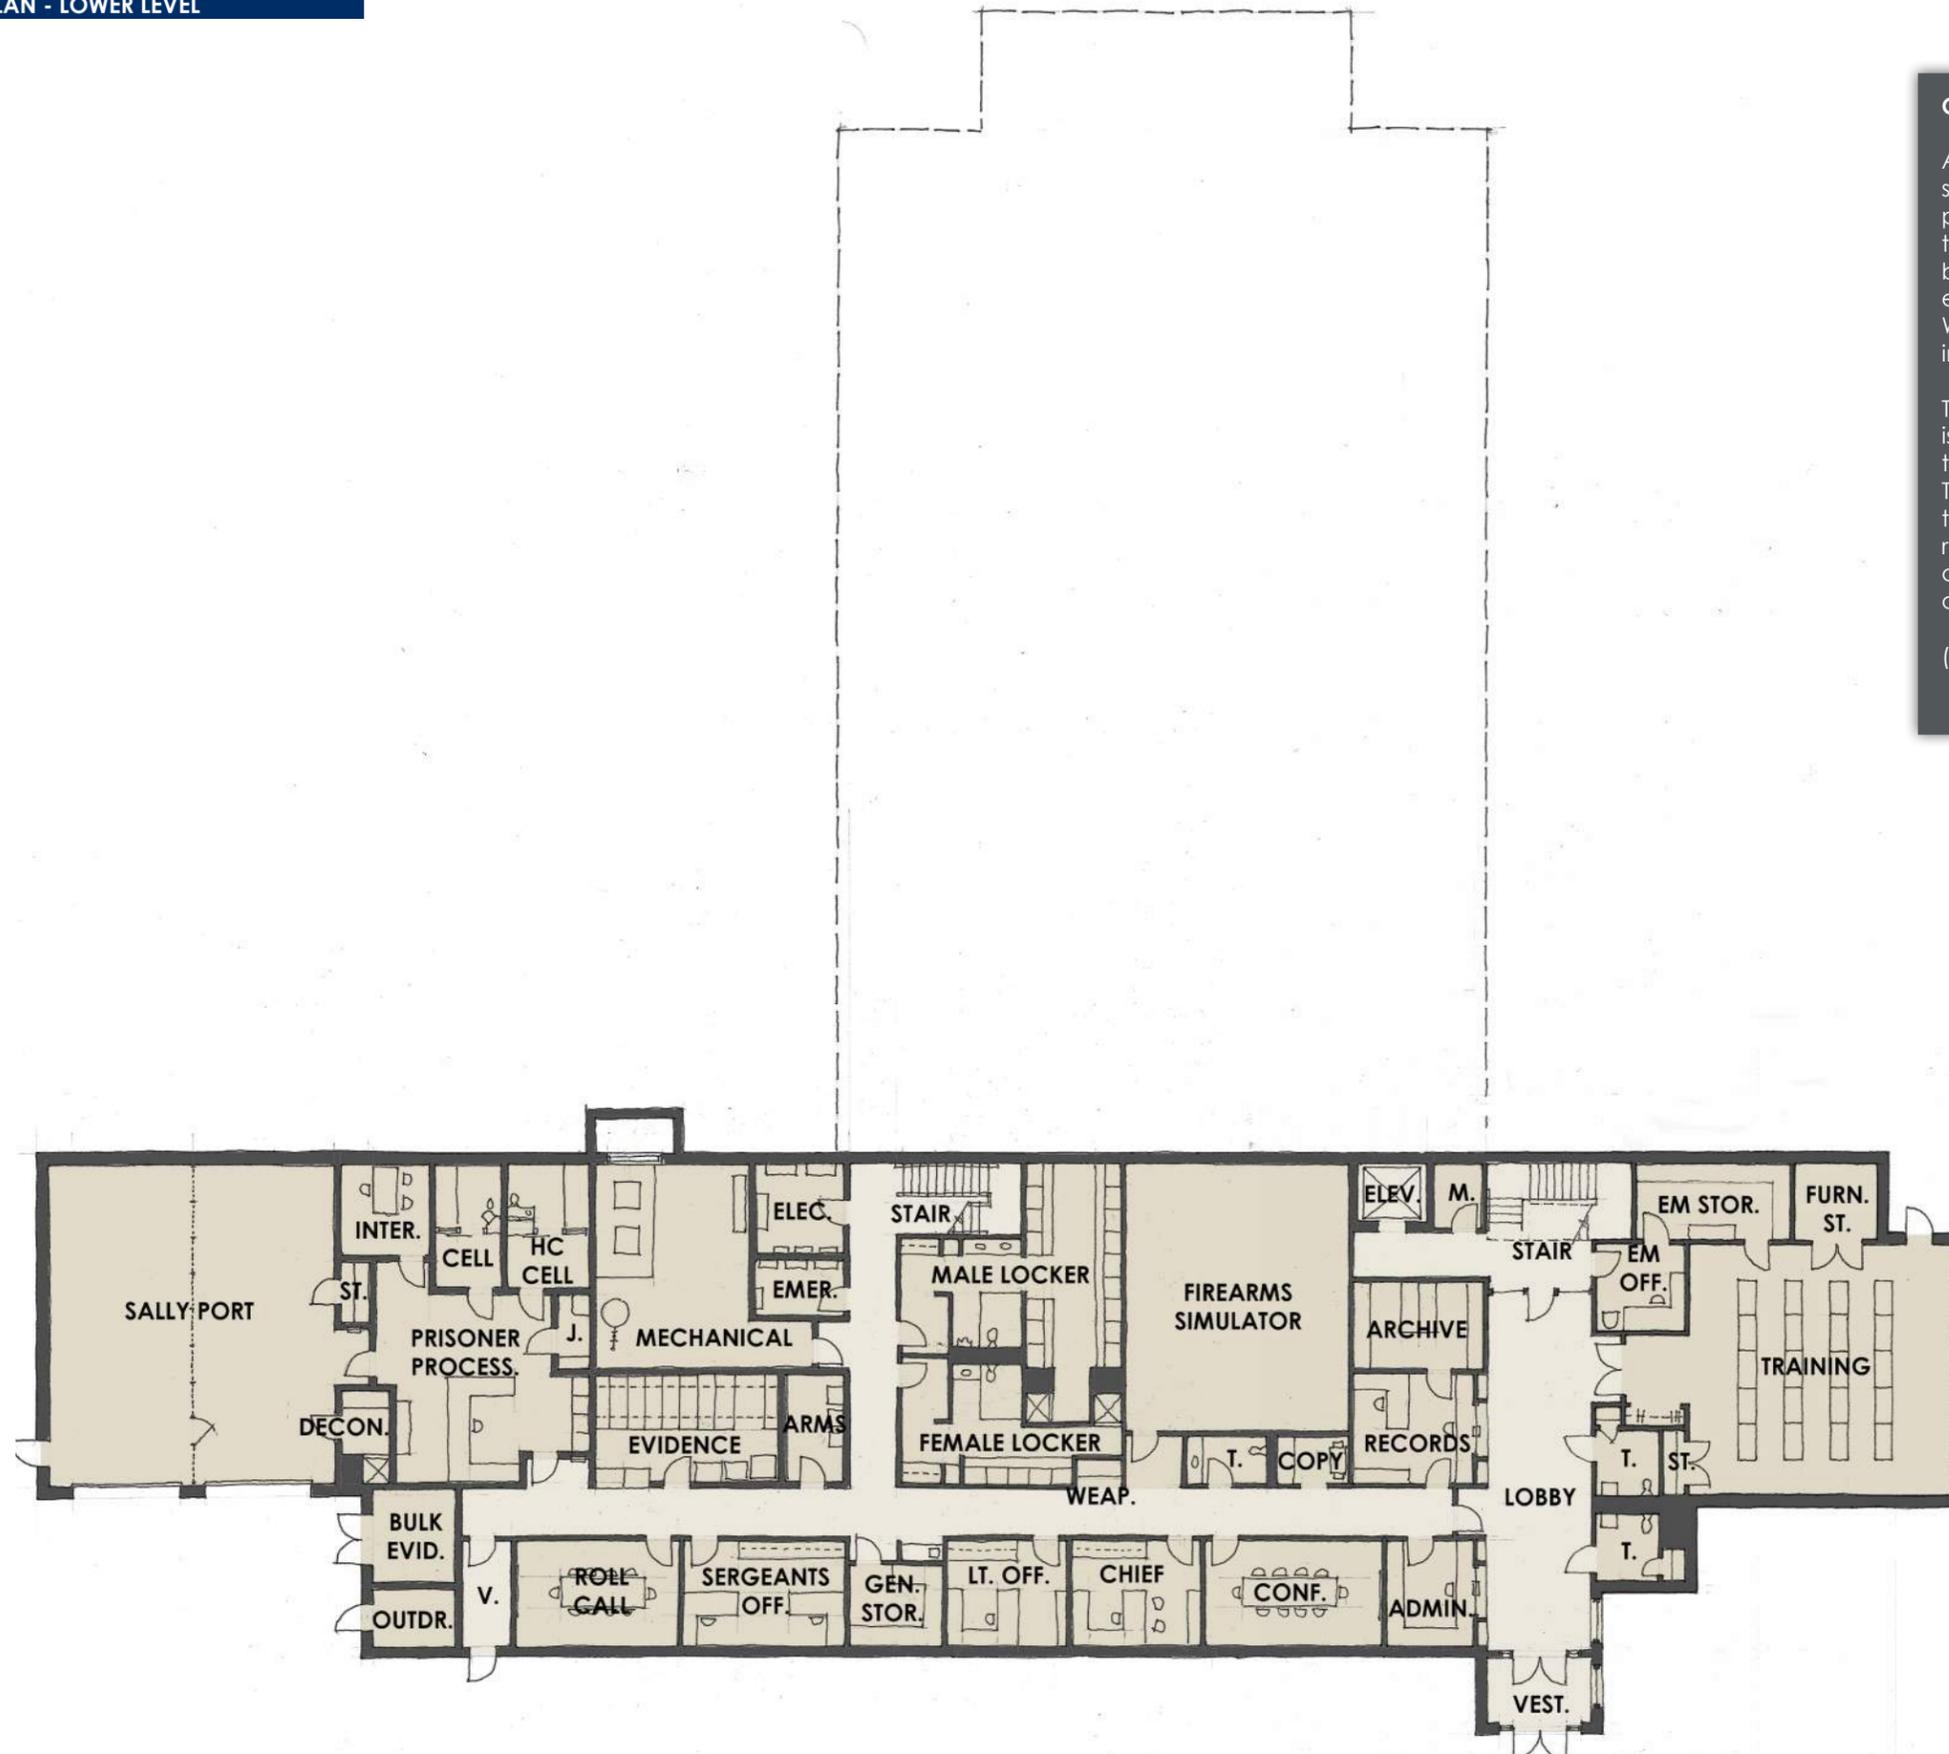
CONCEPTUAL FLOOR PLAN DESIGN

As indicated in the site narrative, the floor plan steps up the slope from Route 67 to Old West Warren Road. The main public entry faces Route 67 and will serve as a way finding tool for public visitors. The apparatus drive loops around both ends of the facility to connect to the primary vehicular entry/exit on Route 67. A rear drive also connects to Old West Warren Road to provide a second exit should an incident occur on Route 67.

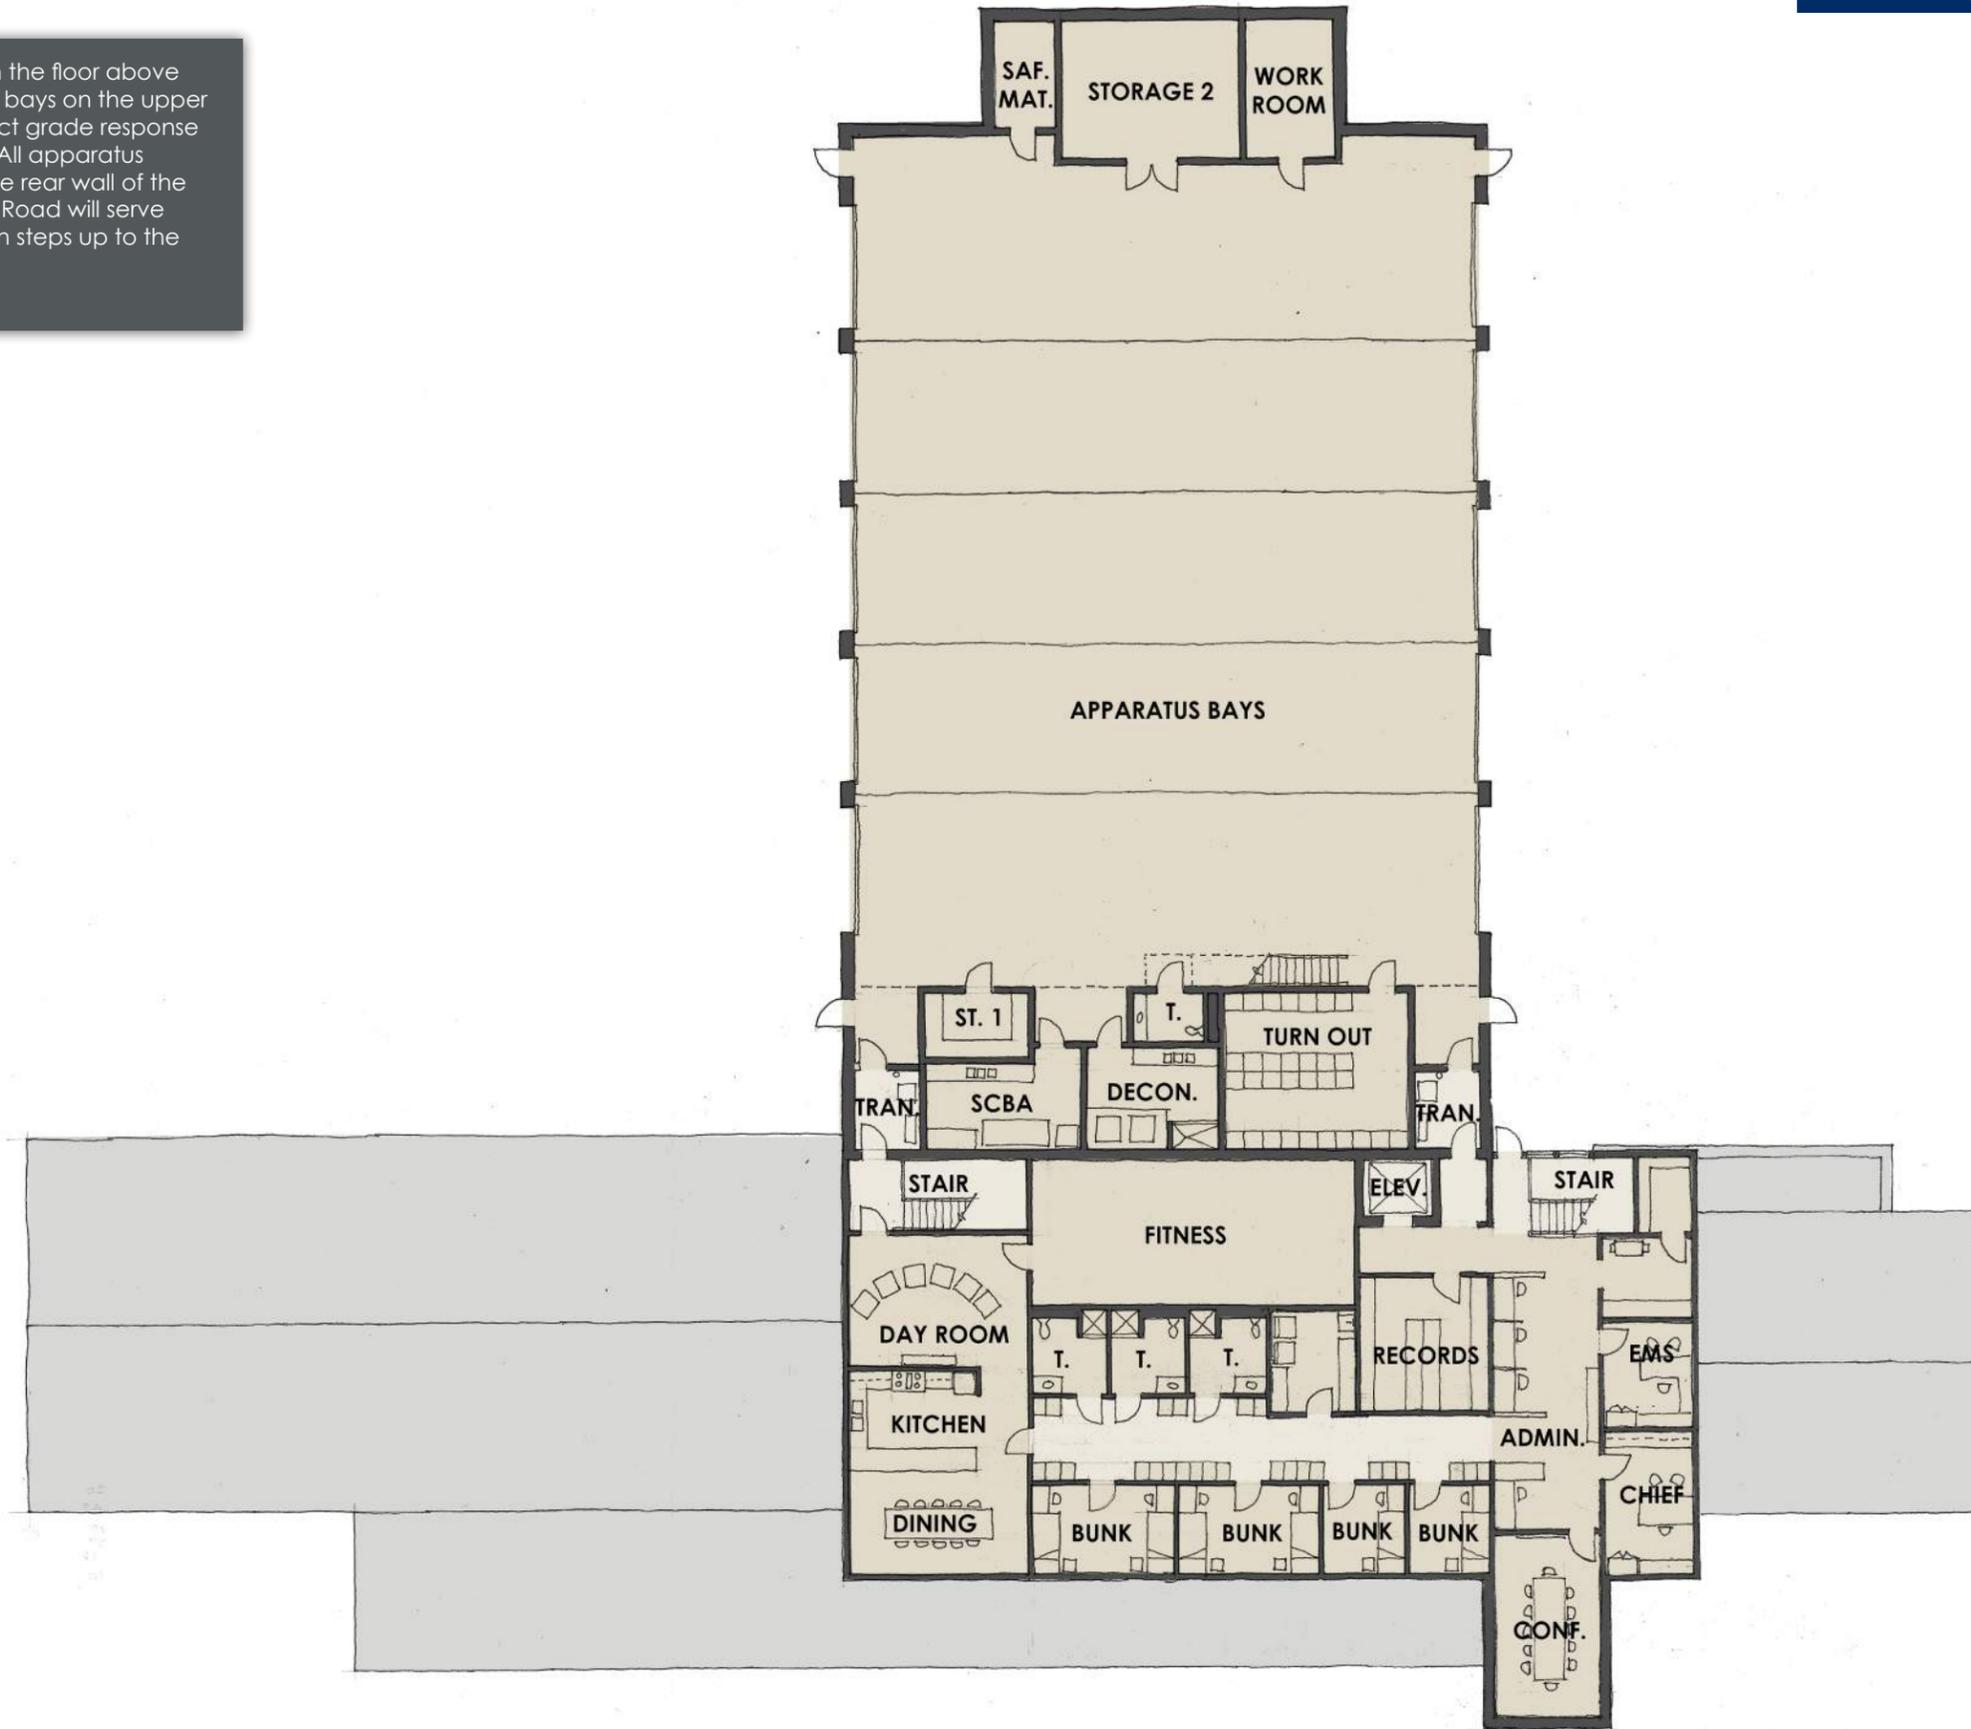
The fire offices and living quarters are on the floor above the police and align with the apparatus bays on the upper tier of the sloping site. This allows for direct grade response routes from the office area to the bays. All apparatus support spaces are flanking the bays. The rear wall of the apparatus bays along Old West Warren Road will serve as a retaining wall as the site once again steps up to the roadway.

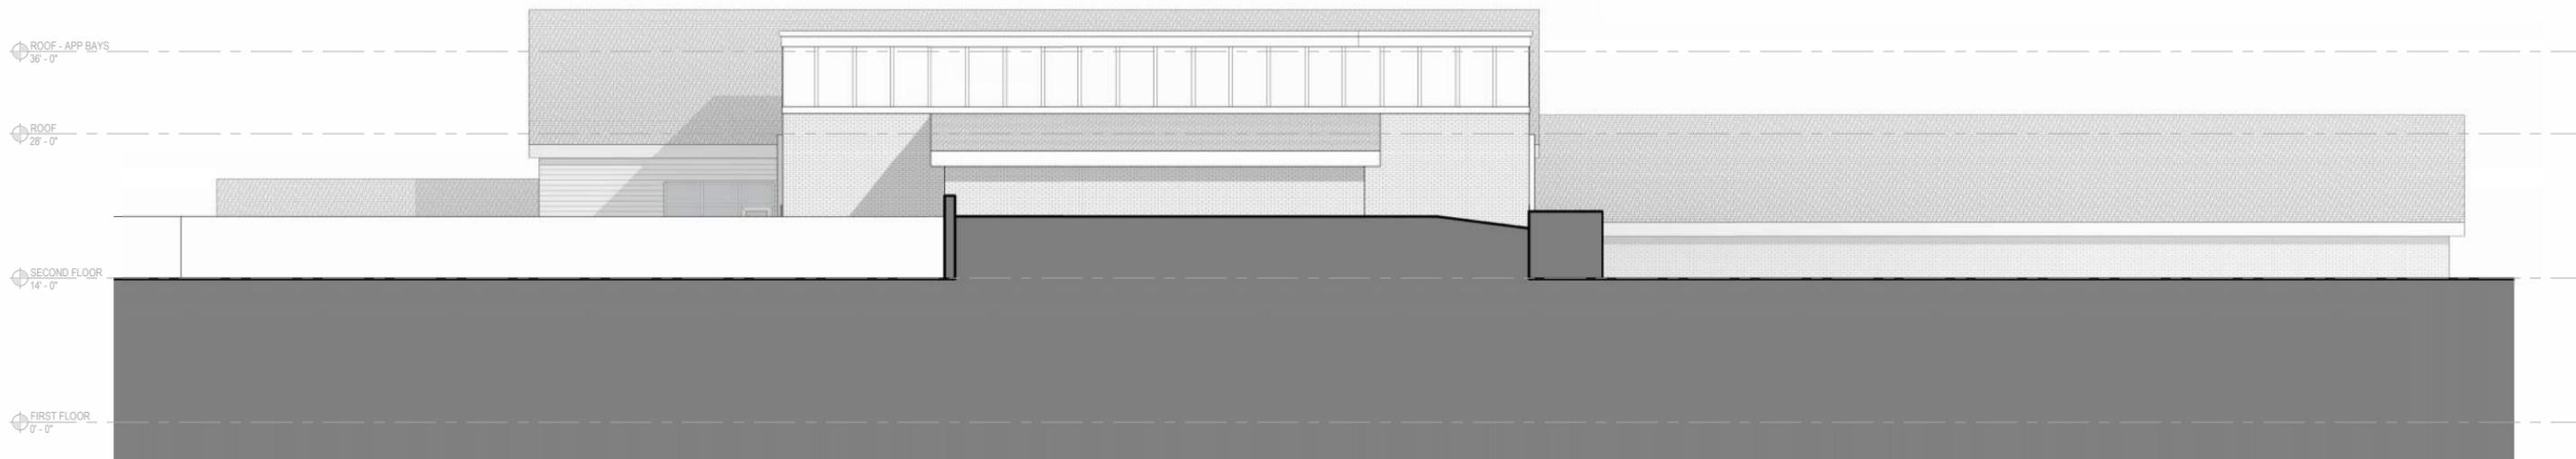
NORTH ELEVATION

The building exterior uses a combination of masonry, cementitious siding, and some metal siding. The two-story mass of the building will be of conventional wood frame construction, while the apparatus bays will use a pre-engineered steel frame, with a combination of masonry and metal siding. The design uses traditional volumes to reflect the character of the community but employs some more contemporary details to demonstrate this is a modern public safety facility.

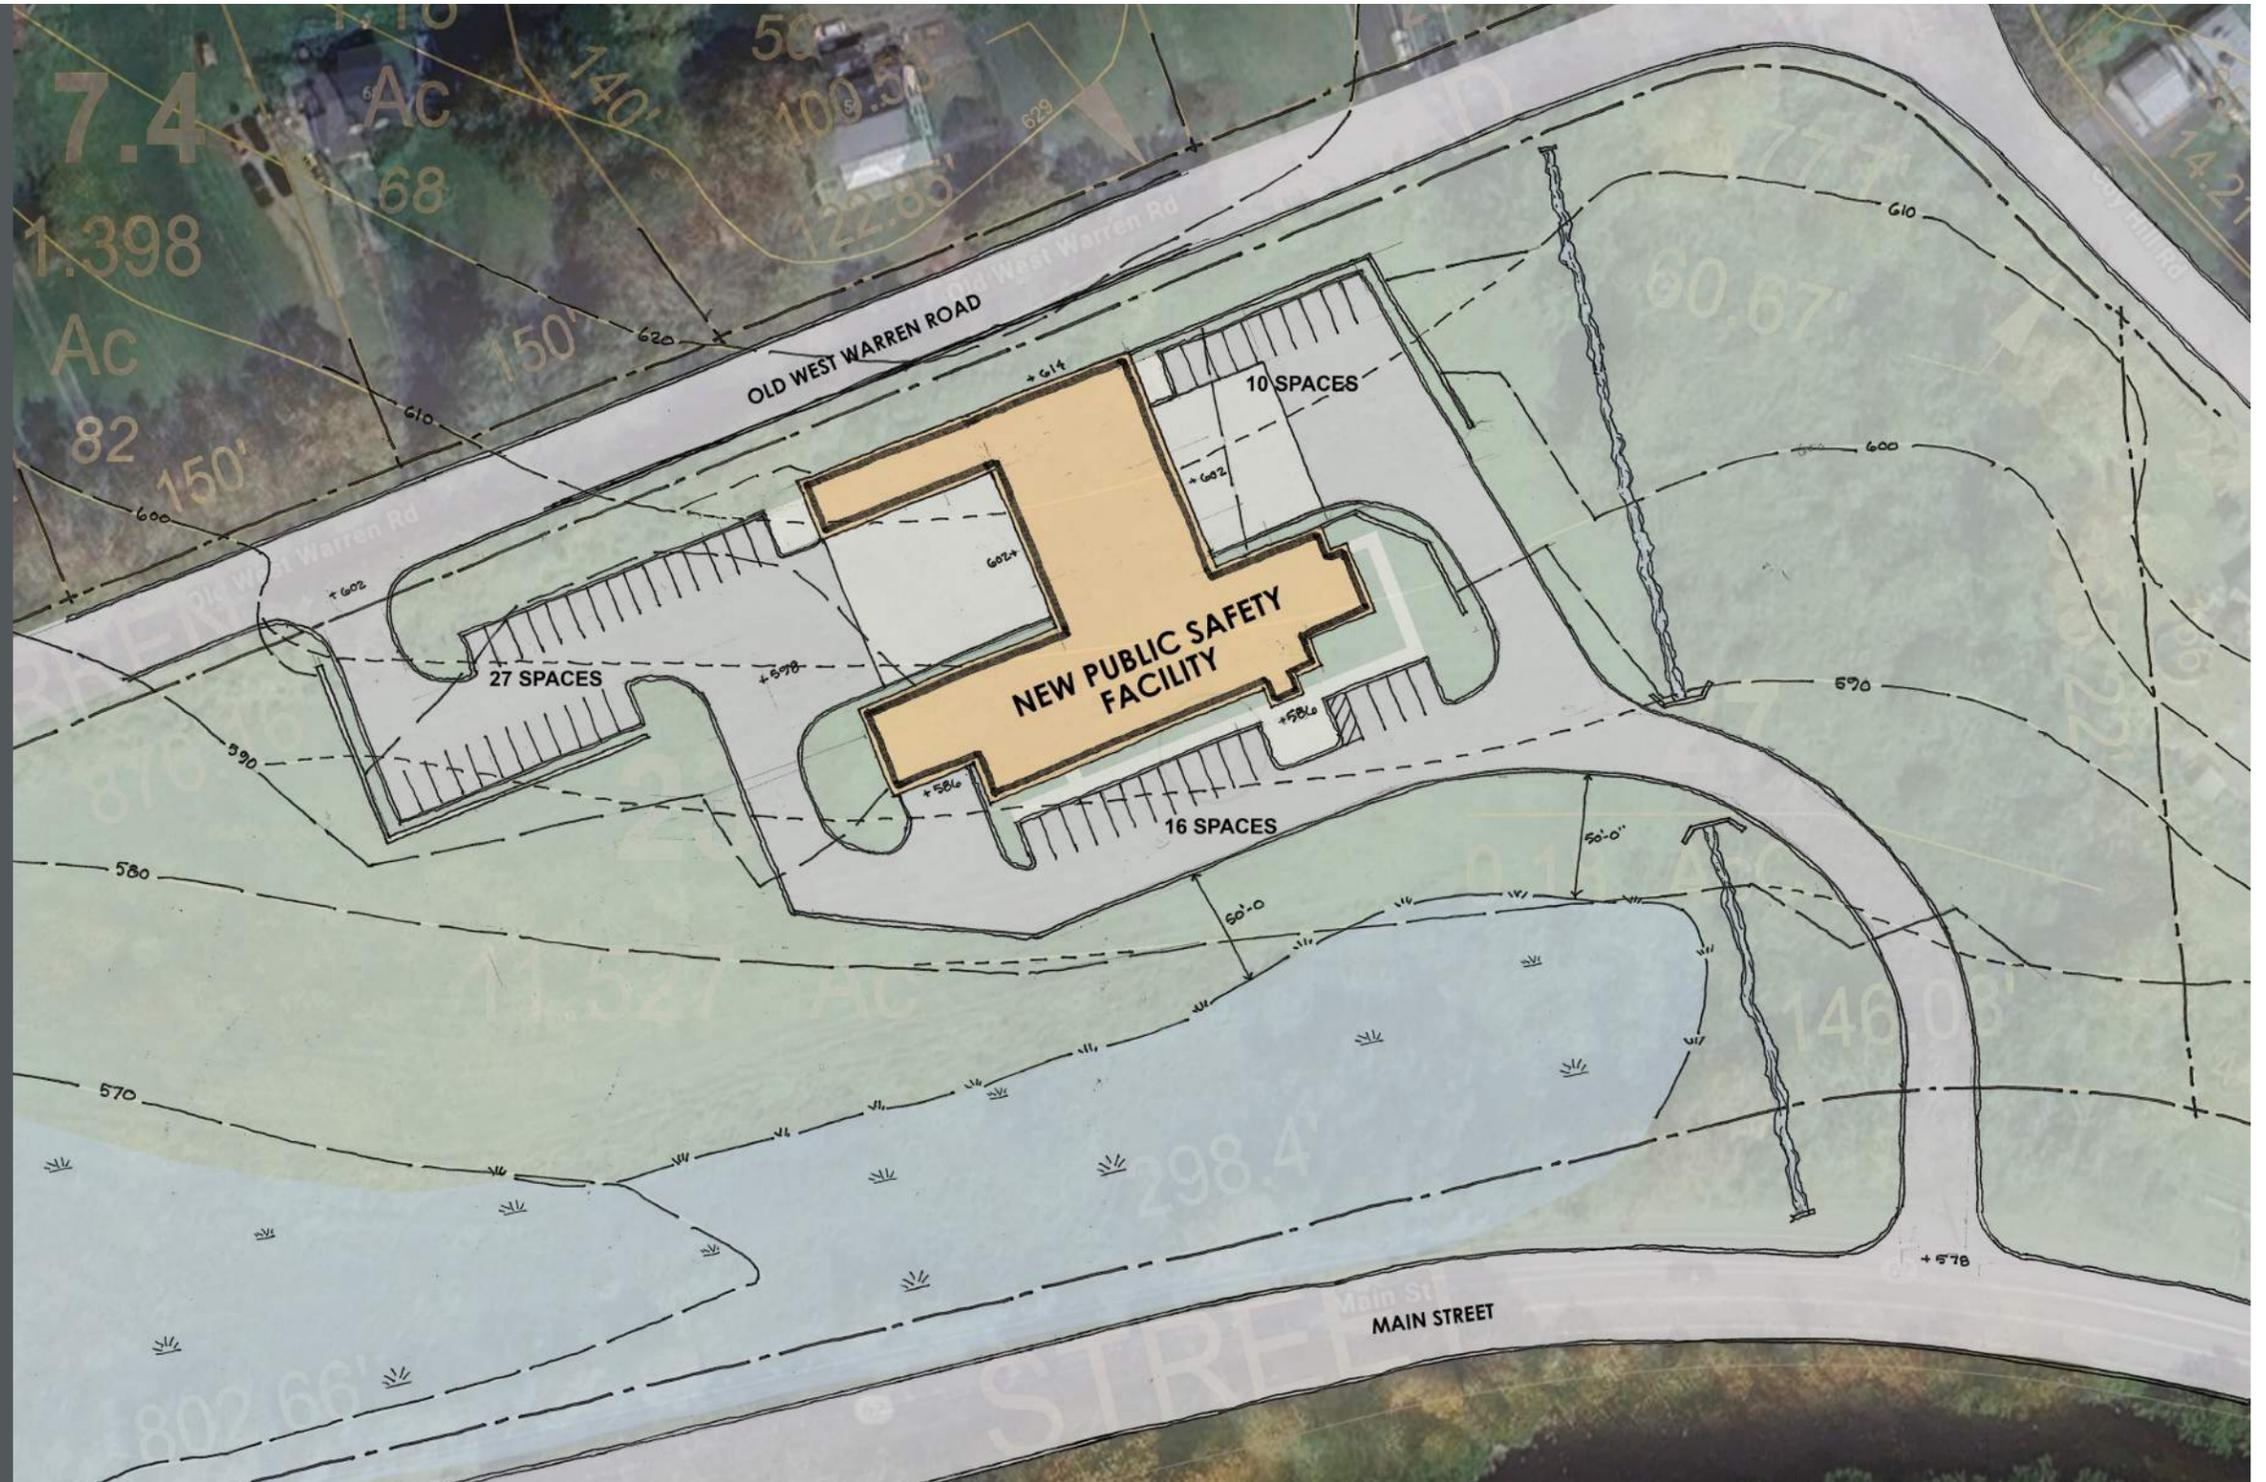
This is the alternative site plan developed in response to concerns expressed by the Conservation Commission. The plan relies on removing one apparatus bay that was programmed to house smaller vehicles and relocating smaller bays along the apron to the west. This move would reduce the overall north to south depth of the building by about twenty-five feet (25') and permits the buffer to the wetland to be increased to the necessary fifty feet (50').
