**Town of Warren  
Self-Evaluation and Transition Plan  
June 2024**

# TOWN OF WARREN – SELF-EVALUATION AND TRANSITION PLAN

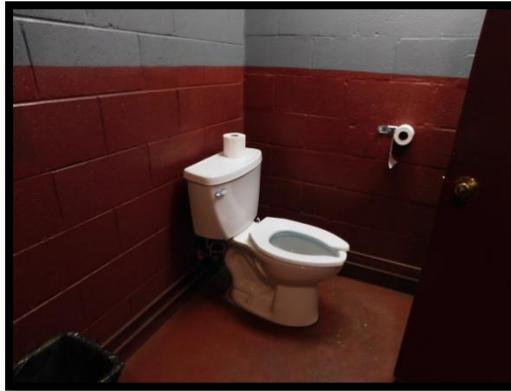
There is a 1 ½" to 2" abrupt change in level surface into the bathroom. The sink piping is not wrapped, guarded, or insulated. The towel dispenser is too high and the toilet paper dispenser is too close to the front of the water closet. The water closet lacks grab bars. A shower is not accessible compliant. [See Photo below.](#)

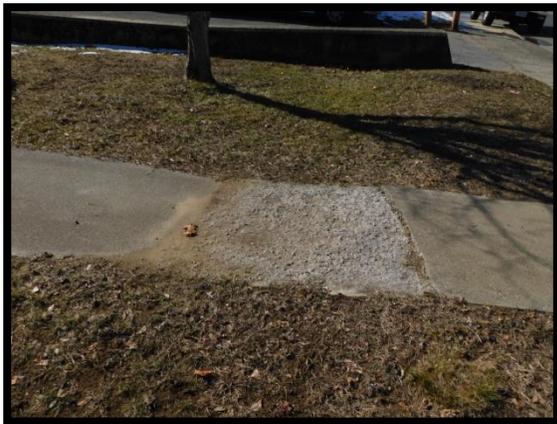
Photo Veterans Park 1

The first concrete pad of the walkway to Veteran's Park from the sidewalk is severely deteriorated resulting in an uneven surface with abrupt changes in level surface of up to 1". The second concrete pad from the sidewalk has a running slope of up to 5.6%, which exceeds the maximum of 5.0% for a walkway. The circular interior walkway has abrupt changes in level surface of up to 2" and gaps in concrete of up to 2". Segments of the circular walkway on the Eagles Building side have sunken and heaved resulting in cross slopes of up to 6.0%.

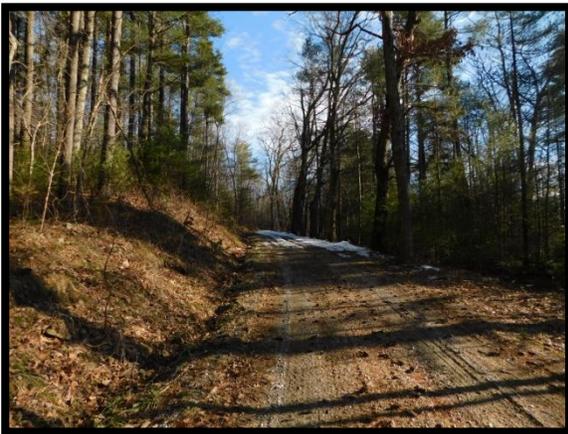
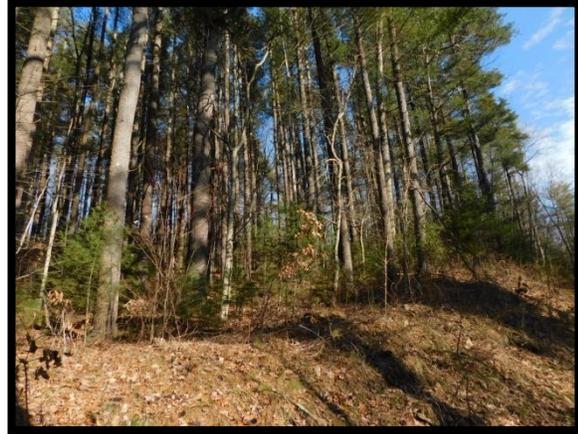
**Function and Description of Facility and Programs:** Tyler Memorial Park is an undeveloped and unimproved site that is not open to the public and is houses the water tower for the water district. Access is limited to an unimproved gravel road which is secured by a gate. The surrounding area is wooded with no improvements. Unless public access including formal parking and improvements are initiated, no further action is required at the present time. [See Photos below.](#)

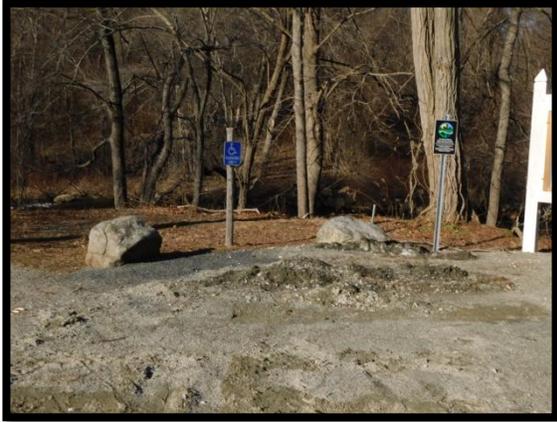
Photo Lucy Stone 1

The stone dust walkway from the parking to the river's edge has loose fines and is not fully compacted. The roughly 55 foot sloped approach from the parking to the area along the river has running slopes that vary up to 11% and cross slopes that vary up to 6.0%. There is no accessible route of travel to the stone bench and to the bench near the river. The picnic table is not accessible compliant.

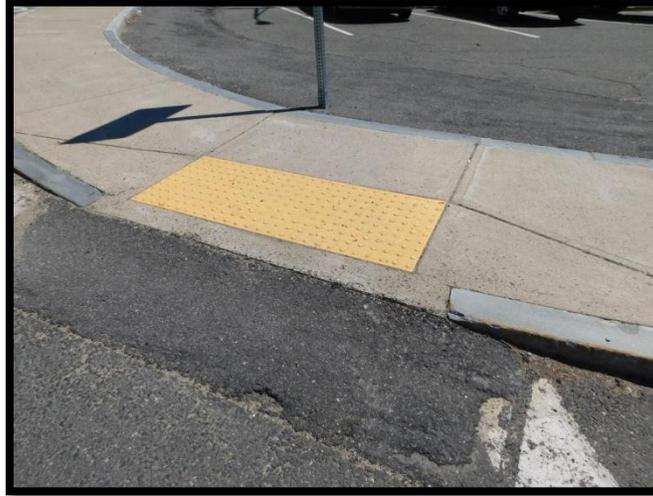
- There is up to a ¾" abrupt change in level surface at the detectable warning strip/curb ramp

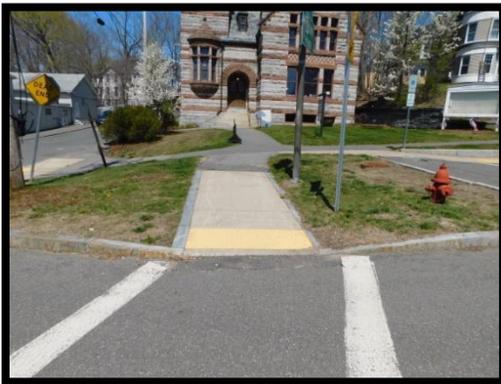
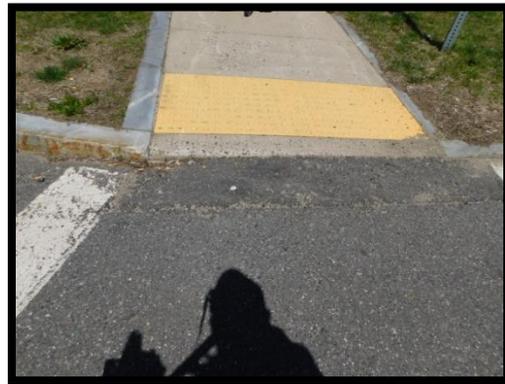
### Curb Ramps at Library

- The curb ramp to the library has up to a 1" abrupt change in level surface at the transition from the roadway and lacks a level landing at the top of the curb ramp
- The curb ramp from the on-street parking lacks a level landing at the top of the curb ramp

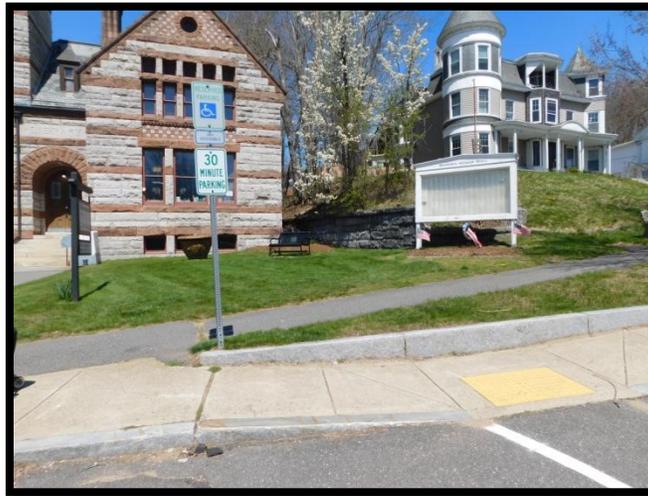
- The signage for the accessible parking space is 11½" too high. The parking space and access aisle have running slopes of up to 4.0% and cross slope up to 7.2%. *Note: Slopes for accessible parking spaces and access aisles should not exceed 2.0% in any direction.*

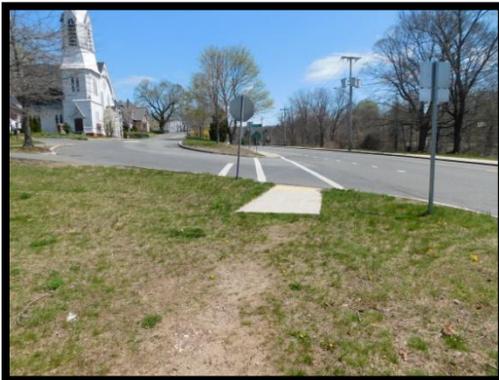
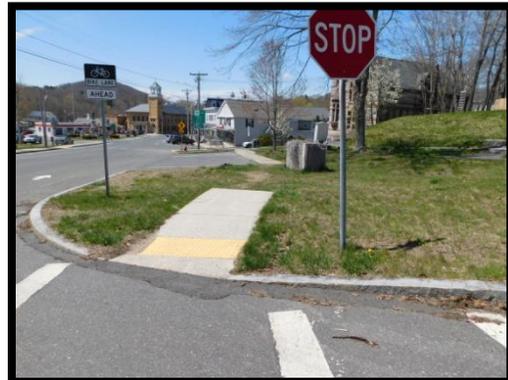
#### Sidewalk and Curb Ramp at Winthrop Terrace

- The sidewalk from the Winthrop Terrace curb ramp terminates and doesn't extend to the sidewalk at the library resulting in approximately 33 feet of unfinished grass and dirt surface.

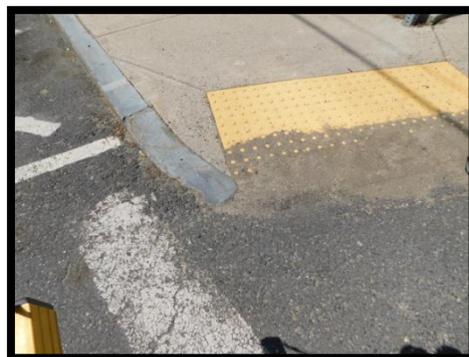
#### Curb Ramp at Bacon Street

- The curb ramp on the library side has up to a  $\frac{3}{4}$ " abrupt change in level surface. The curb ramp on the opposite side (business district side) has an accumulation of debris at the base of the ramp.

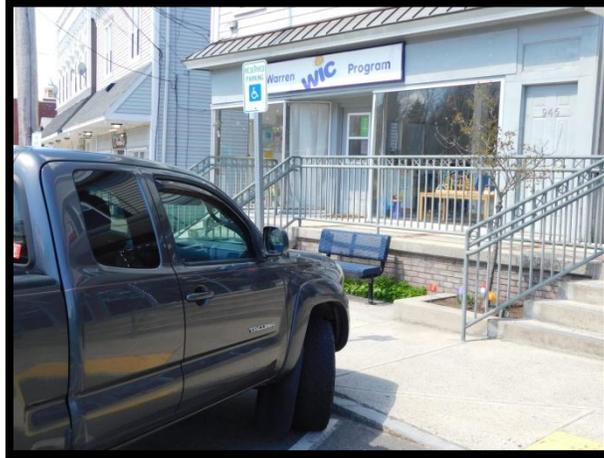
- The signage for the accessible parking space is 7” too high. The parking space and access aisle have running slopes of up to 4.4%. *Note: Slopes for accessible parking spaces and access aisles should not exceed 2.0% in any direction.* Although the space and access aisle meet the width requirements for a van accessible space, there is no “Van Accessible” signage.

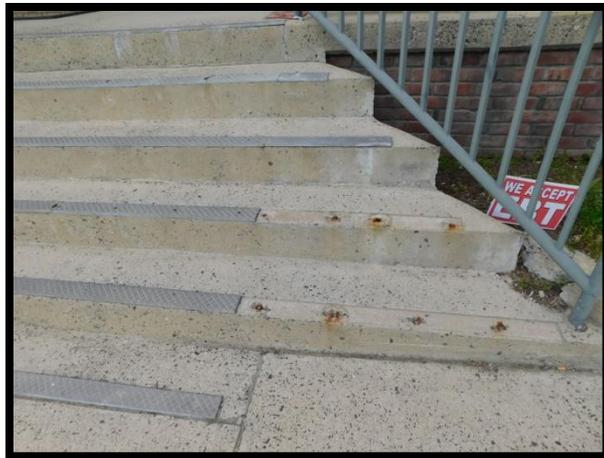
### Stairs to Businesses

- The stairs at the Dance School and One Stop Market have railings that are 1” to 2” too low. There are also areas of deterioration on the stair treads.

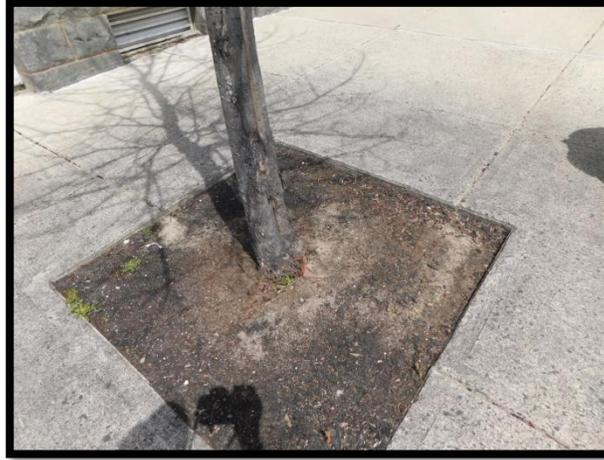
### Ramp to Businesses

- A tree well is creating a 1½” abrupt change in level surface and tripping hazard.

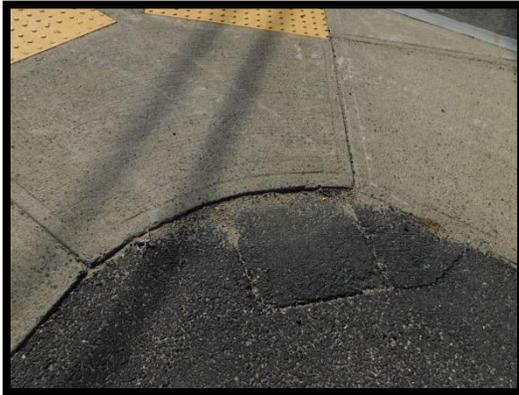
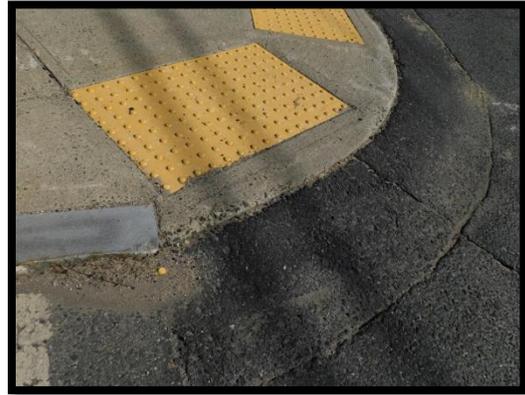
Curb Ramp at Police Parking

- There is a ½” to 1” abrupt change in level surface at the curb ramp to the parking and the curb ramp to the street at the transition from concrete to asphalt.

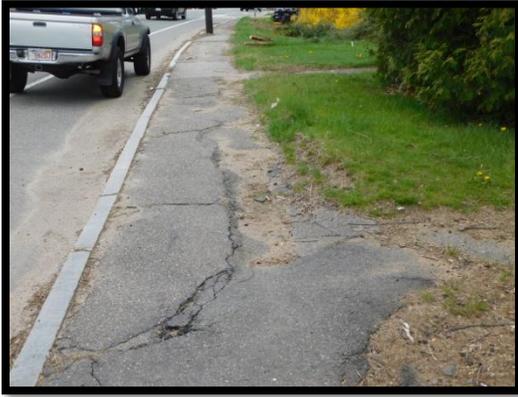
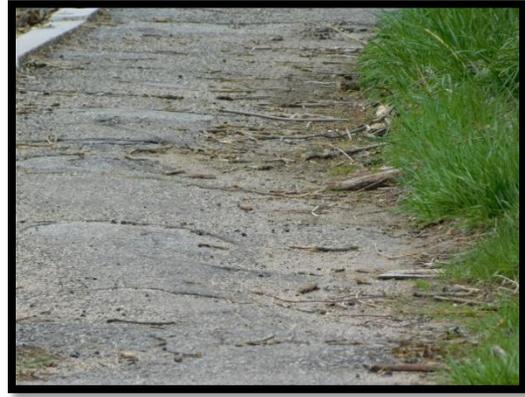
- The asphalt sidewalk leading to Cutter Park is severely deteriorated with heaving and abrupt changes in level surface

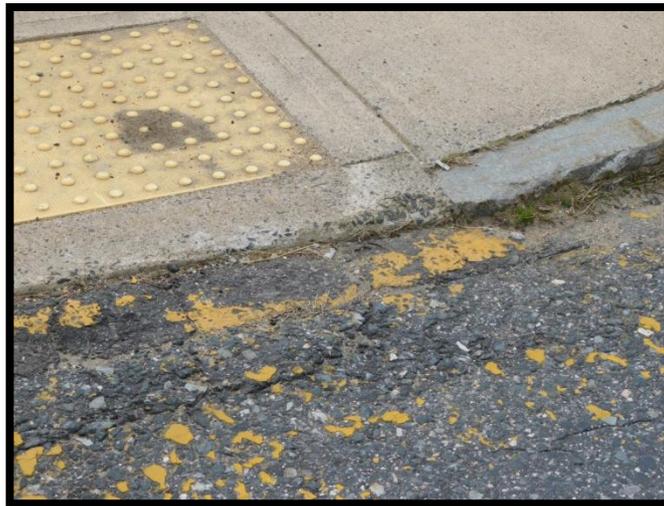
### Crosswalk and Curb Ramps at Bridge Street

- The crosswalk is faded. The curb ramp on the Cutter Park side has up to a 1" abrupt change in level surface.

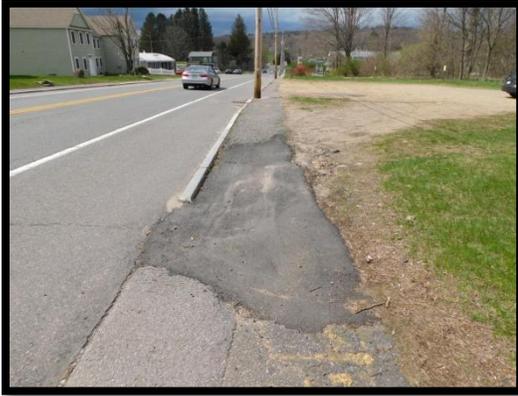
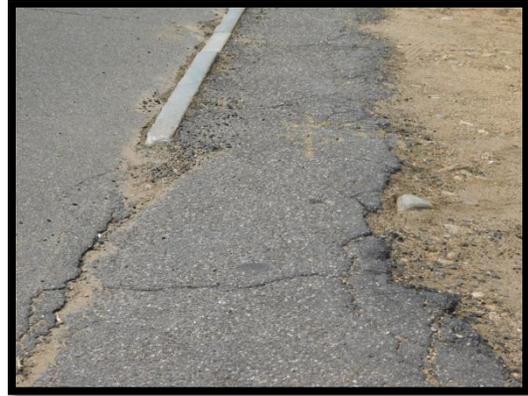
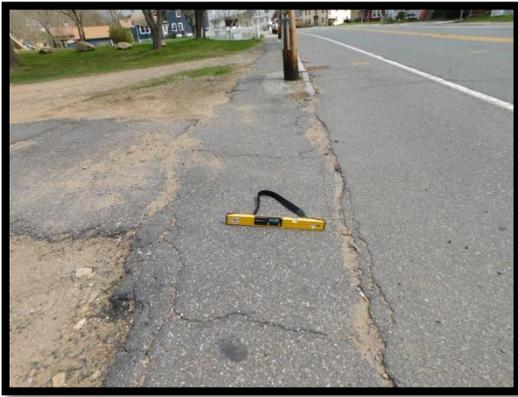
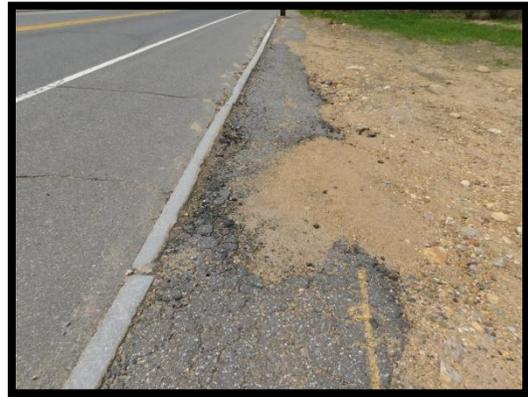
### Sidewalk from Cutter Park to the Mobile Station

- The sidewalk is severely deteriorated with heaving and numerous abrupt changes in level surface. There are areas with cross slopes of up to 14.8% and a clear width reduction to 10" or less.

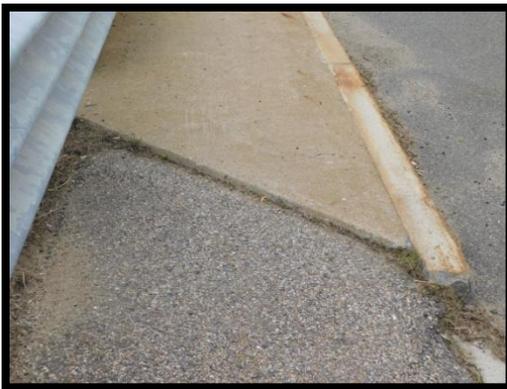
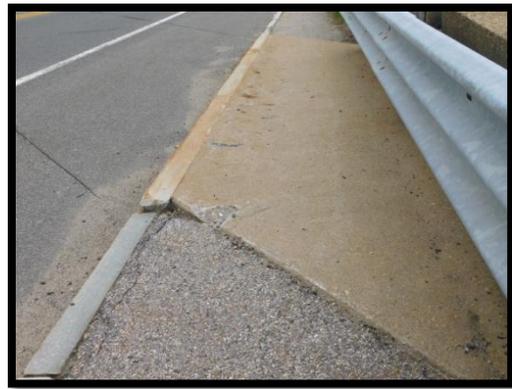
Sidewalk from the Mobile Station to Coy Hill Road

- The sidewalk is severely deteriorated with heaving, abrupt changes in level surface, and with cross slopes of up to 20%. There are abrupt changes in level surface of up to 1" at the transition from asphalt to concrete at the bridge.

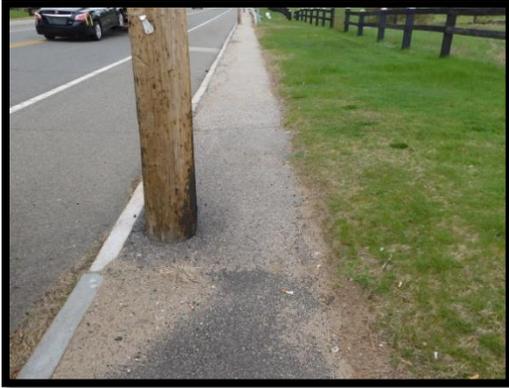
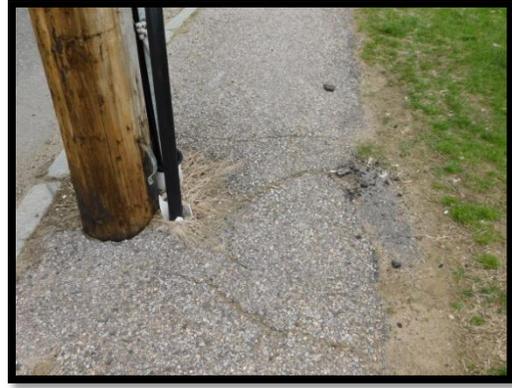
- Telephone Poles MECO #61, #62, #63, and #64 have reduced the sidewalk clear width to 24" to 32". In addition, there is related sidewalk deterioration and abrupt changes in level surface.

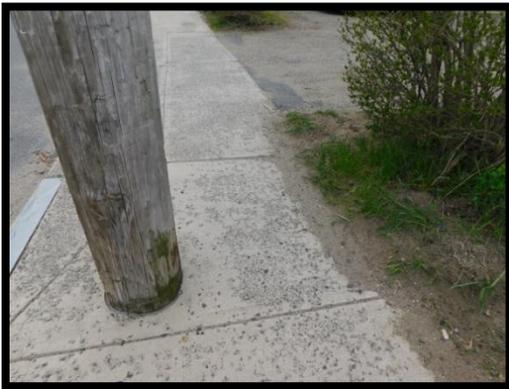
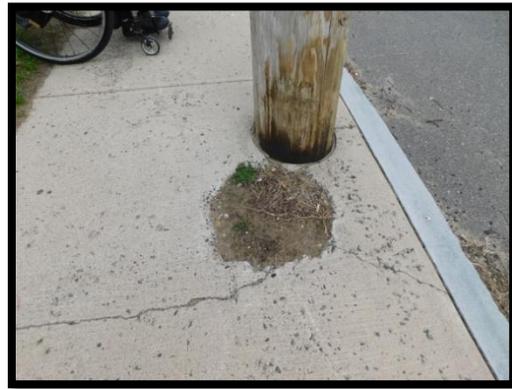
#### **Telephone Poles**

- Telephone Pole MECO #142 (near #2294 Main Street) has reduced the sidewalk clear width to under 32". The removed pole at Pole #144 (near Spring Street) has created a ½" to ¾" abrupt change in level surface where the old telephone pole was located.

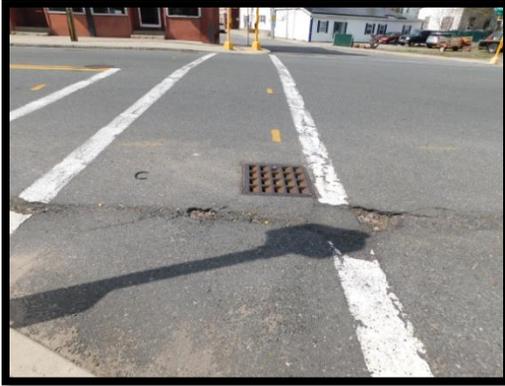
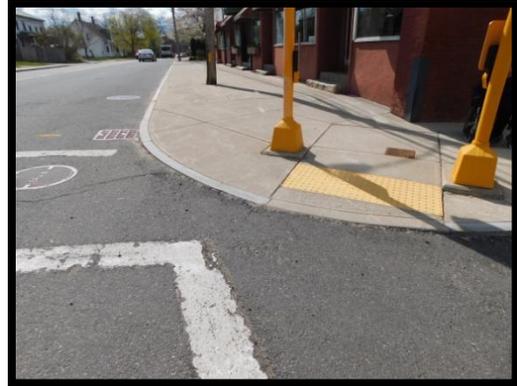
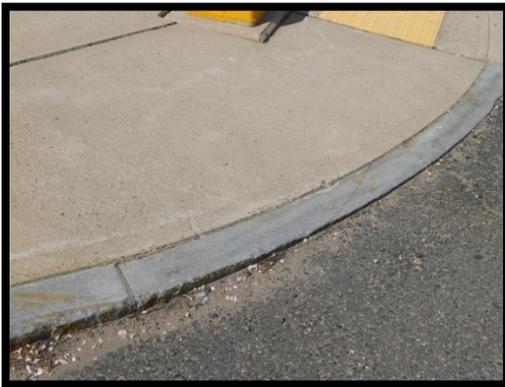
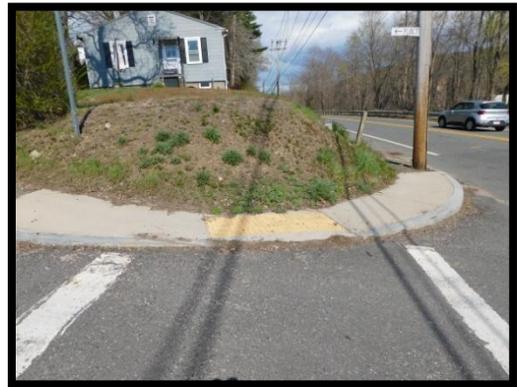
#### **Curb Ramps and Crosswalks**

- Post Office. The curb ramp at #2277 to the Post Office has a ¾" abrupt change in level surface.
- South and Main Street across South Street. The curb ramp on both the east and west sides lack level landings at the top of the ramps.
- South and Main Street across Main Street. The crosswalk across Main Street has abrupt changes in level surface of up to 1½" due to holes in the asphalt. A storm drain with grate openings of 3½" x 4½" is located in the middle of the crosswalk. The curb ramp on the North Street side is an apex curb ramp.
- Old West Warren Road. The curb ramps lack level landings.

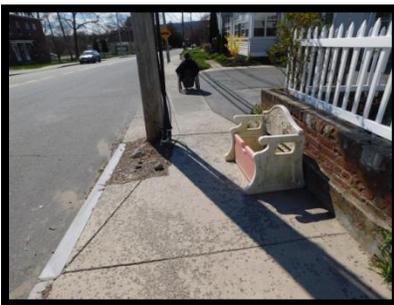
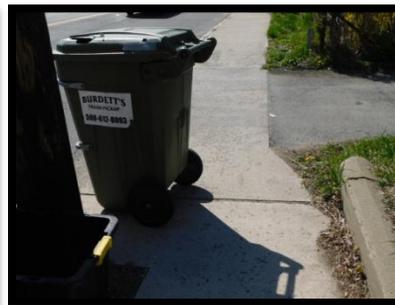
Sidewalks from South Street to the Senior Center

- Items placed in the sidewalk near #2198 reduce the clear width to under 32”.
- A trash receptacle at #2210 reduces the sidewalk clear width to under 32”.
- Vegetative overgrowth at #2230 reduces the headroom of the accessible route of travel and is also a protruding object.
- A trash receptacle at the Village Market restricts the clear width to under 32”.
